**LIFE HISTORY OF USS PLAINVIEW (AGEH-1)  
HYDROFOIL POWER TRANSMISSION SYSTEM**

by  
**Henry W. Schab**

December 1980

DTNSRDC-80/109

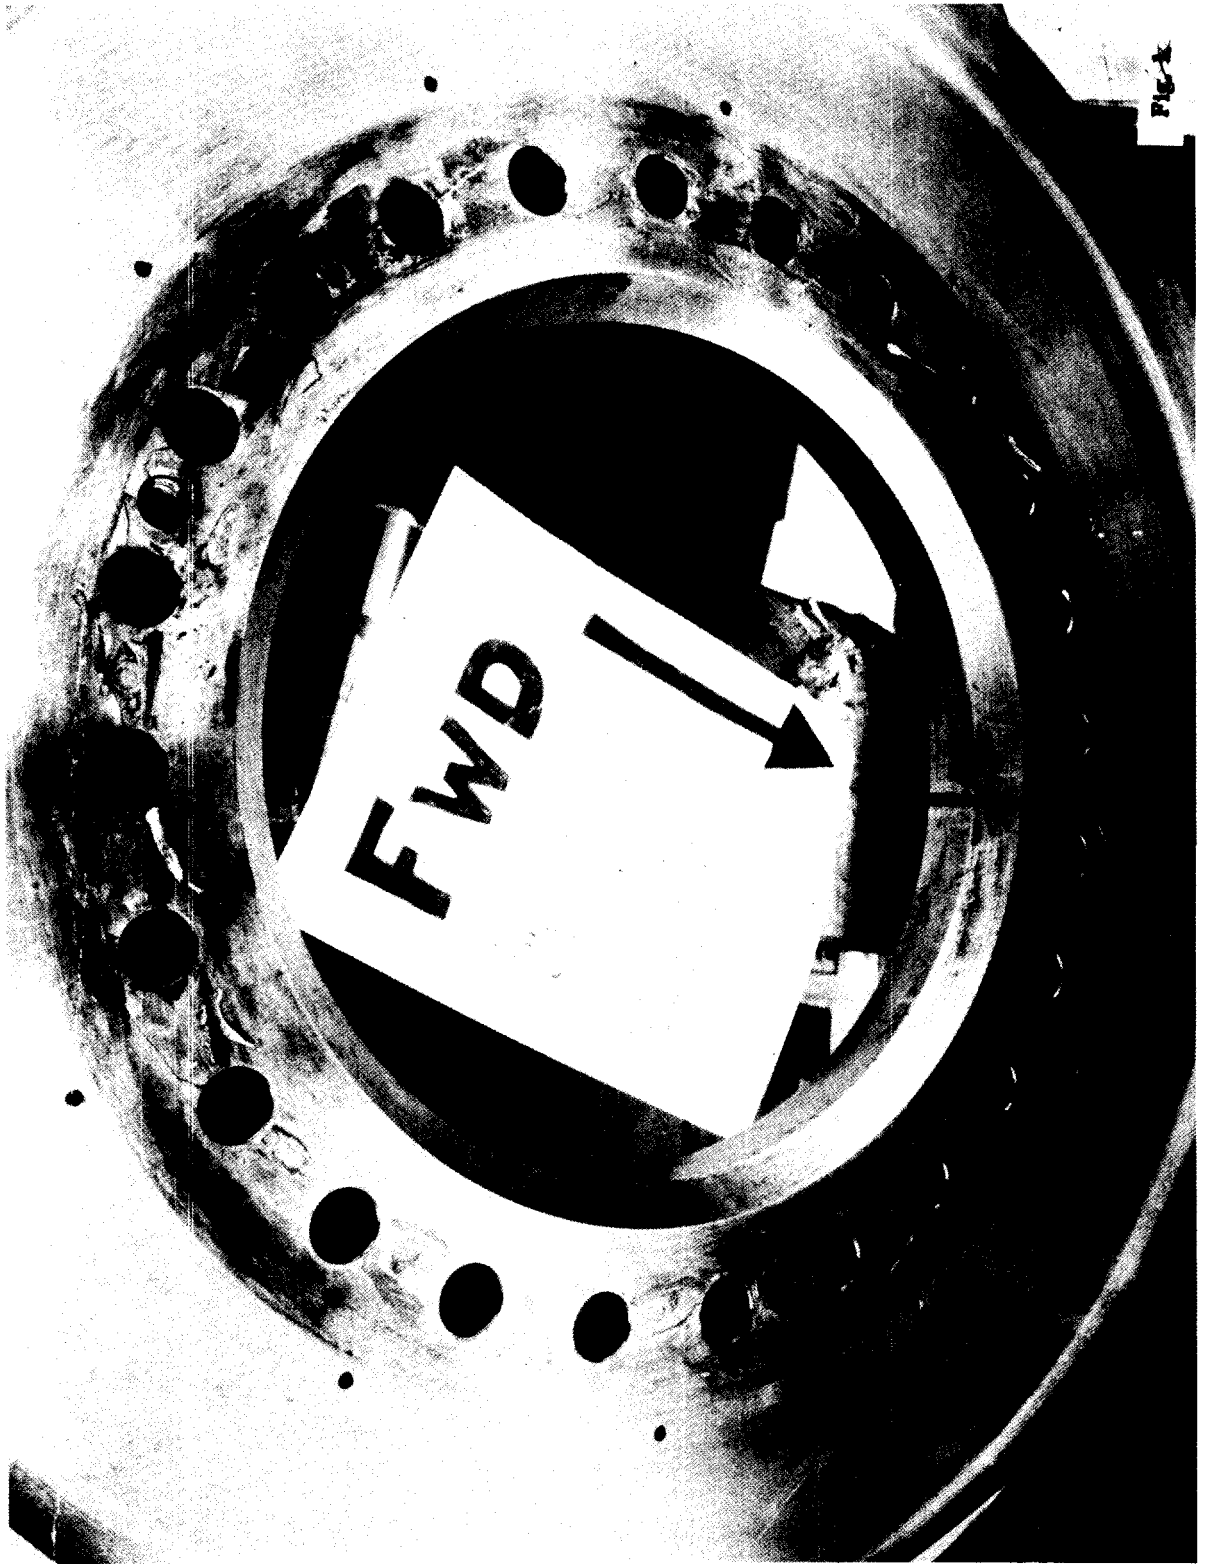
Fig-8

The gears were inspected by the magnaflux process; there was no apparent failure or distress noted in the teeth. However, after the last magnaflux inspection, at the end of the 100 percent load tests, observations showed that gear webs had developed longitudinal cracks; they traveled from bolt hole to bolt hole (Figure 8). Twelve cracks in the web flanges were found between bolt holes, and one crack not located at a bolt hole.

It was believed that the cracking was associated with fretting corrosion: fretting had been observed after all the first three development test runs. In an attempt to minimize the effects of fretting, lubricant was added to the shims in the gear-shaft assemblies. The web and hub mounting areas also showed signs of fairly intensive fretting.

Fretting corrosion is known to cause cracking of steel at stress levels as low as 8,000 psi, regardless of the physical properties of the material. In general, fretting has been a common problem in lightweight high power transmission systems wherever two surfaces are bolted or pinned together and exposed to high vibratory energy.

Subsequent analysis, reported by Smith,<sup>1</sup> indicated that the flange face fretting and cracks were at least partly due to the method of testing. Figures 3 and 4 show the unsymmetrical force reaction tending to bend the output gear

Figure 8 - Test Gear with Cracks in Gear Web

flange and gear assembly. This force pattern, which can be cyclical, produces a traveling wave as the gears pass through mesh. Small motions of deflection can cause sliding between the gear flange and the shim, thus causing fretting. It was surmised that the ship installation and operation would not produce such a similar traveling deflection wave through mesh; it was assumed that the forces would be symmetrical with no resulting deflection.

1. Replace steel shims between gears and shaft with "fretting resistant" silver-plated bronze shims.
2. Shot-peen mounting surfaces of gears and shafts, thereby reducing tendency to crack by inducing a residual compressive stress.
3. Coat gear flange face and locating bore with Teflon. (This is generally an effective lubricant to retard fretting.)
4. Install body-bound fitted bolts between gear flanges to reduce slippage and movement. (Since the mounting surfaces are lubricated, torque will be transmitted almost entirely by the bolts.)

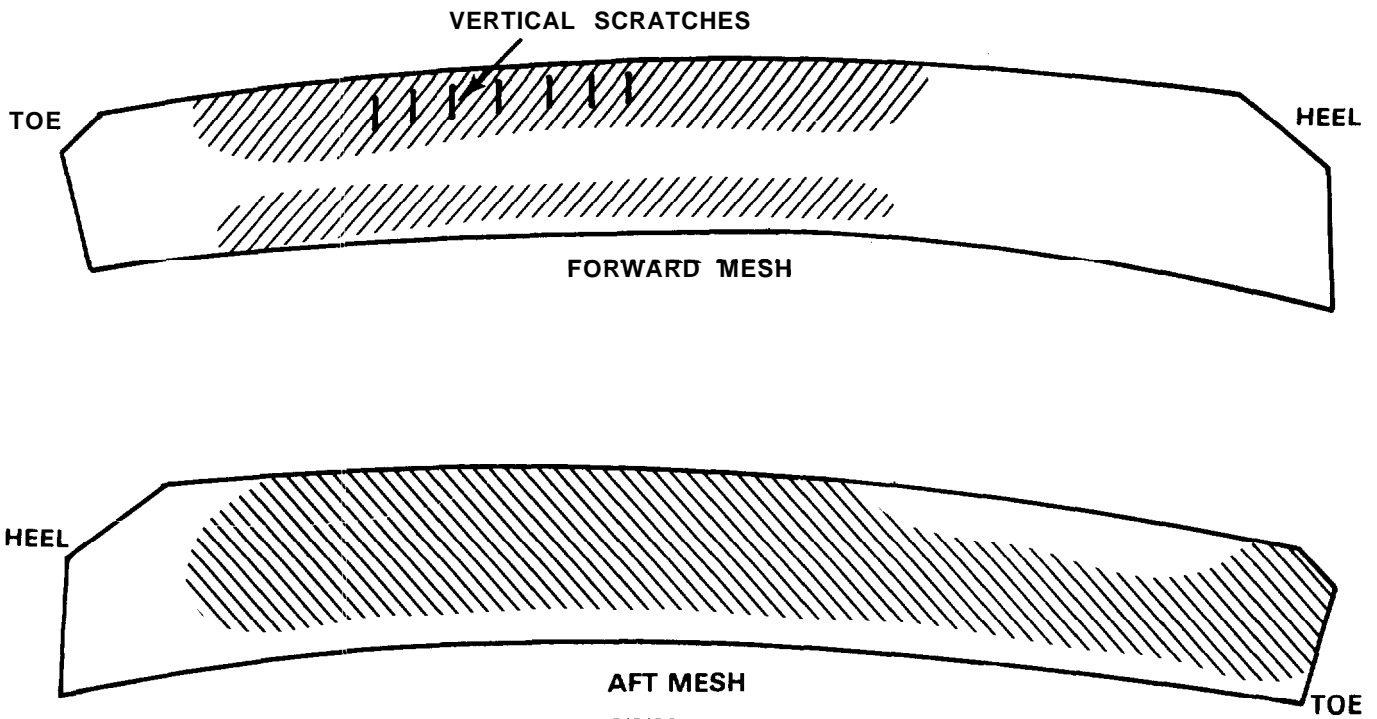
Note: Tape taken from GE during inspection on 12/3/68 after 5 hours operation.

Figure 9 - Tooth Contact Pattern: Port Lower Bevel Gear, at 5 Hours of Operation

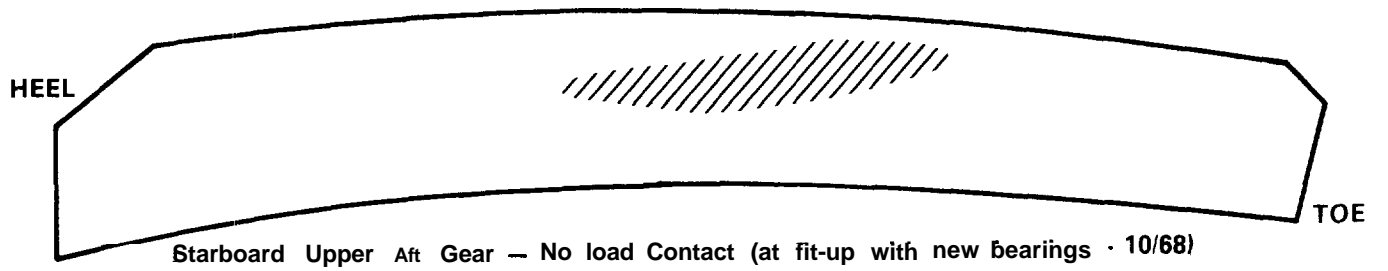
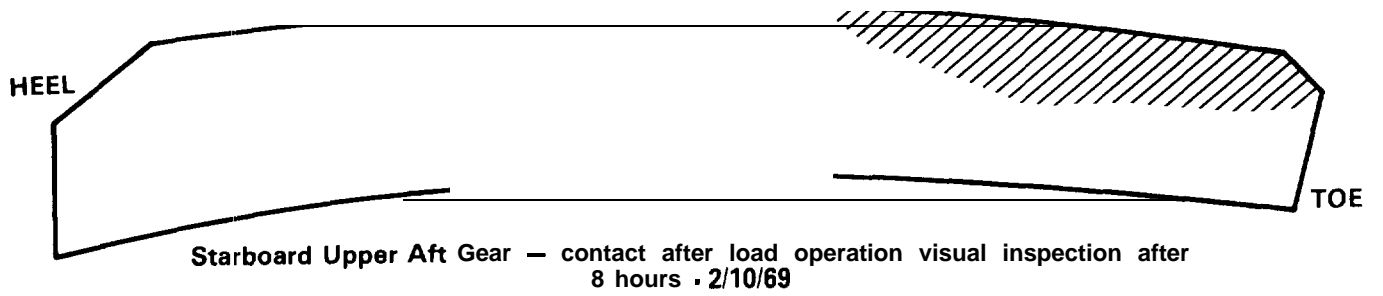
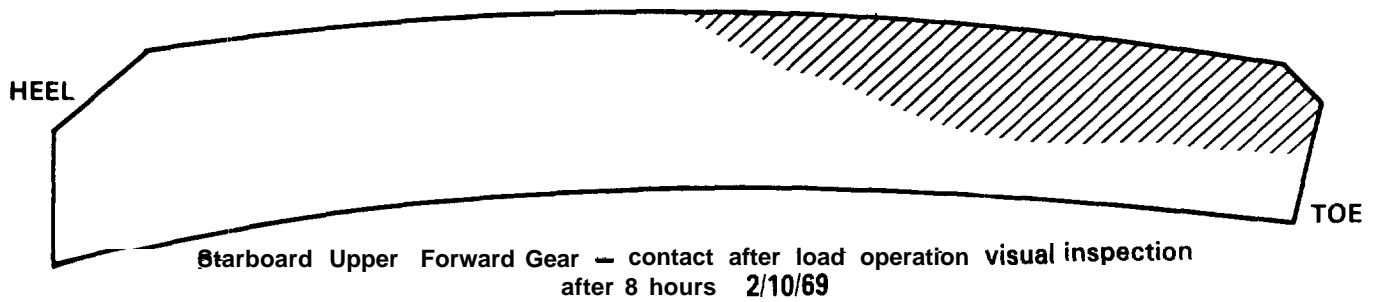
In February 1969, a DTNSRDC technical representative inspected the gearboxes at the request of SUPSHIP 13. Approximately 8 hr of foilborne operation has been accumulated prior to this inspection. The double wear pattern on the port gears showed no increase or deviation from the December 1968 inspection (Figure 10). Apparently, a "polishing" action between mating surfaces was taking place and a "run-in" had been achieved. The starboard gear tooth patterns deviation was not considered serious but for long term operation, a closer scrutiny was recommended.

Figure 10 - Tooth Contact Pattern: Upper Starboard Aft and Upper Starboard Forward Gears, at 8 Hours of Operation

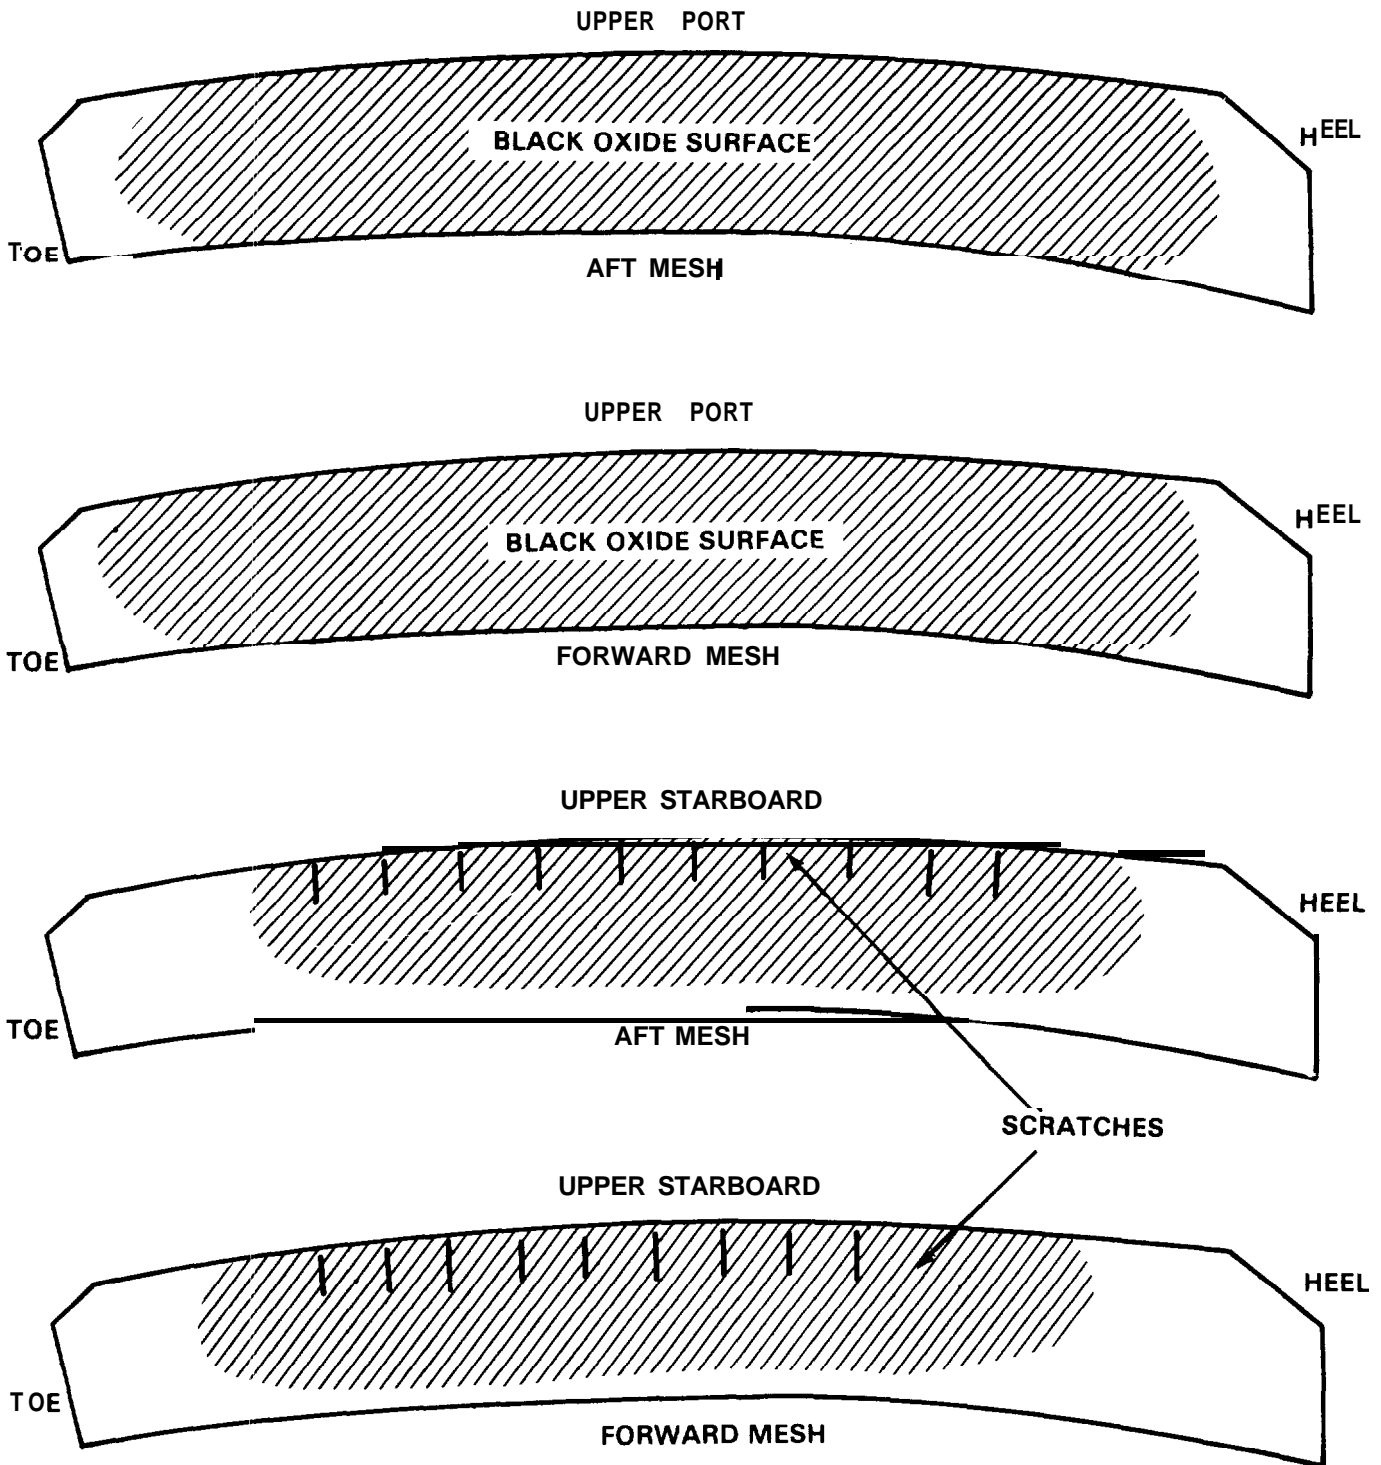
An inspection of the bevel gears was made in June 1969 after approximately 14 hr of foilborne operations.<sup>12</sup> Three of the four gearboxes were examined, both upper gearboxes (port and starboard) and the lower port box. In both the upper gearboxes, good tooth contact was observed and no wear pattern was visible; thus,

it was concluded that gear operation was in the region of hydrodynamic lubrication (Figure 11). The lower port gear again showed some metal-to-metal contact over approximately 50 percent of the contact surface; this same pattern was observed in the mating pinion. However, there was no progressive deterioration observed. A question was raised about the determination of the proper backlash for the gears. Earlier, GE had attributed some of the test gear failure to improper backlash, thus indicating that backlash was critical. A GE assembly drawing showed that the recommended backlash was approximately four times larger than that recommended by Gleason Works Company. GE was contracted for clarification.

Note: Inspection after 14 hours of operation • 6169.

Figure 11 - Tooth Contact Pattern: Upper Port and Starboard Gears, at 14 Hours of Operation

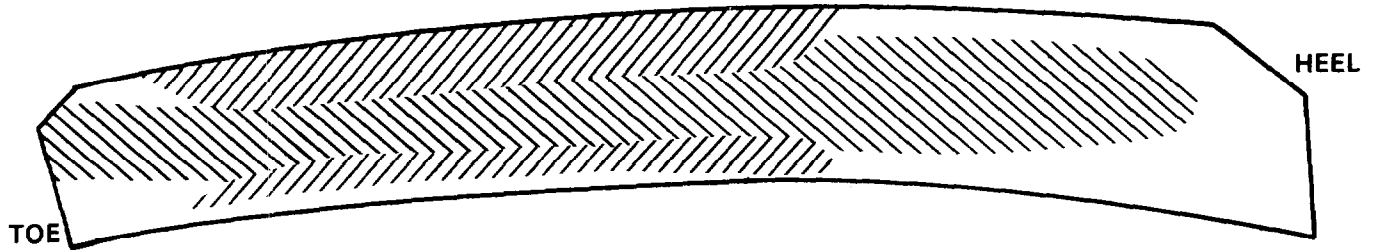
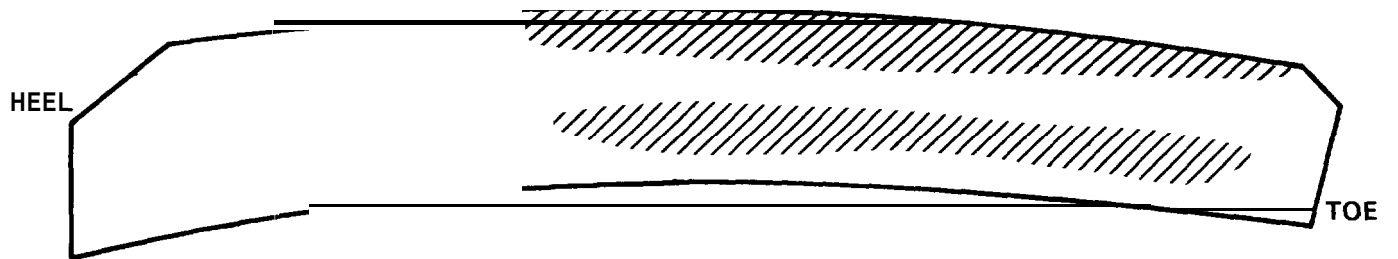
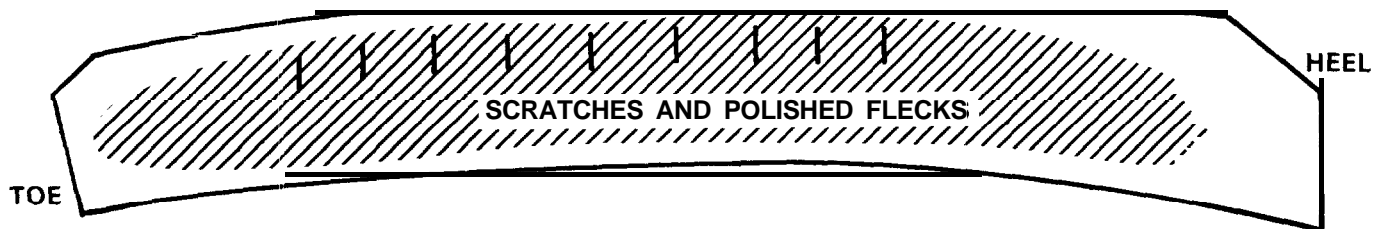
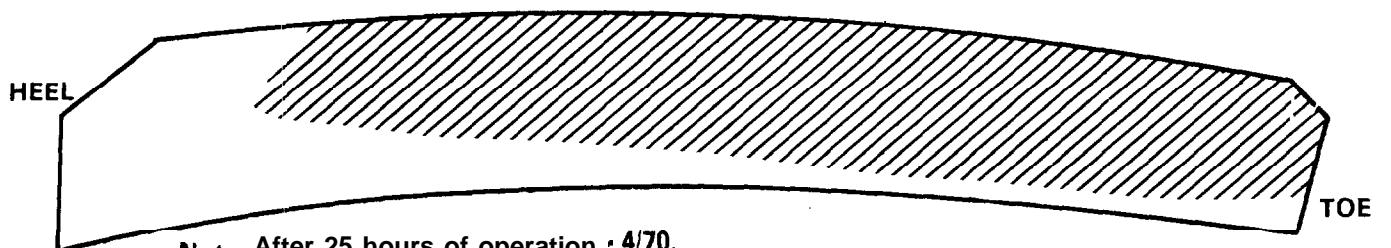
Note: After 25 hours of operation - 4/70.

Figure 12 - Tooth Contact Pattern: Port Lower Gear and Pinion, at 25 Hours of Operation on April 1970

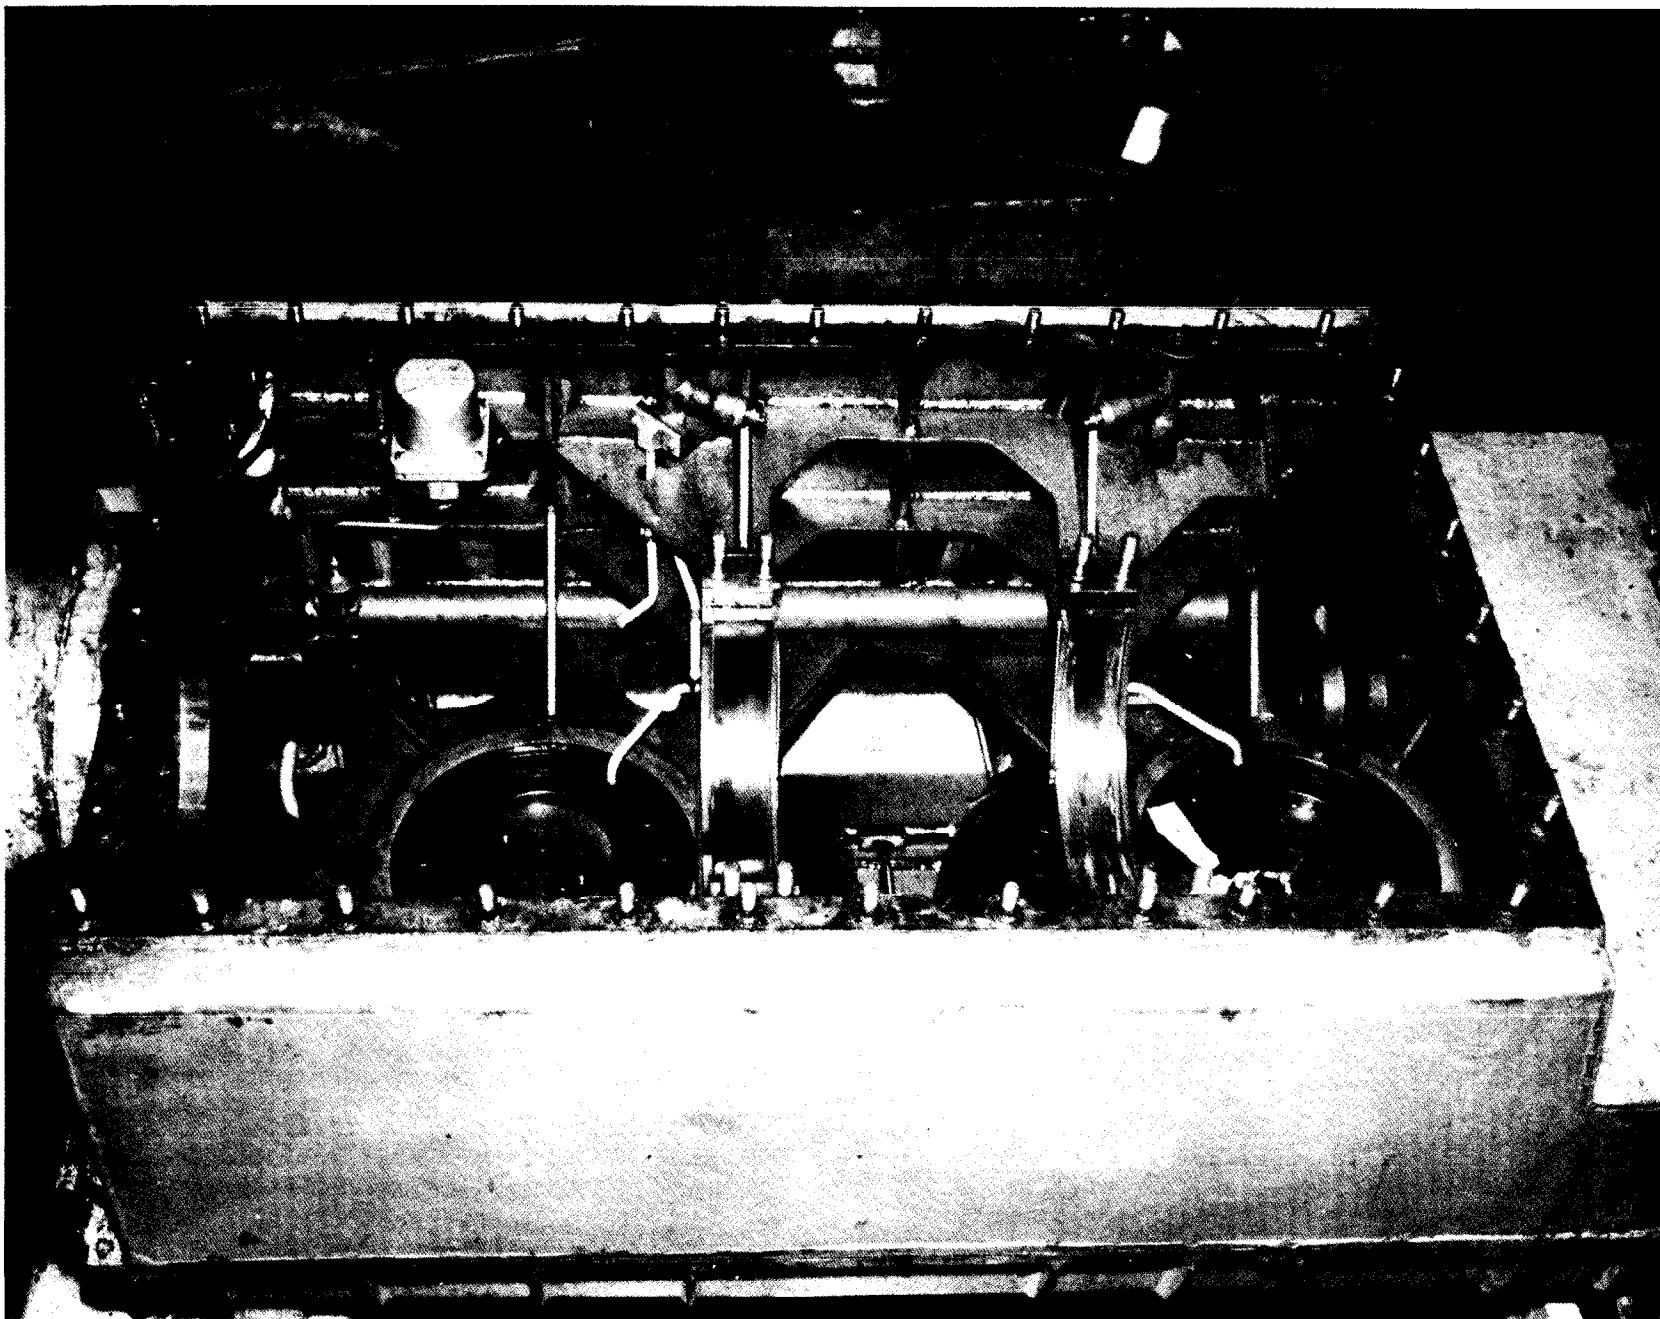
The bevel gears in the lower gearbox appeared to be in very good condition. There were a few small superficial rust spots on the teeth that were easily wiped off, and some rust was seen on one of the roller bearings in the lower box. Again, only small portions of the bearing race were visible.

Figure 14 - Open Gear Box

Water was found as usual in the various compartments formed in the gearbox by the stiffeners. (Note: This is a design deficiency which requires correction.)

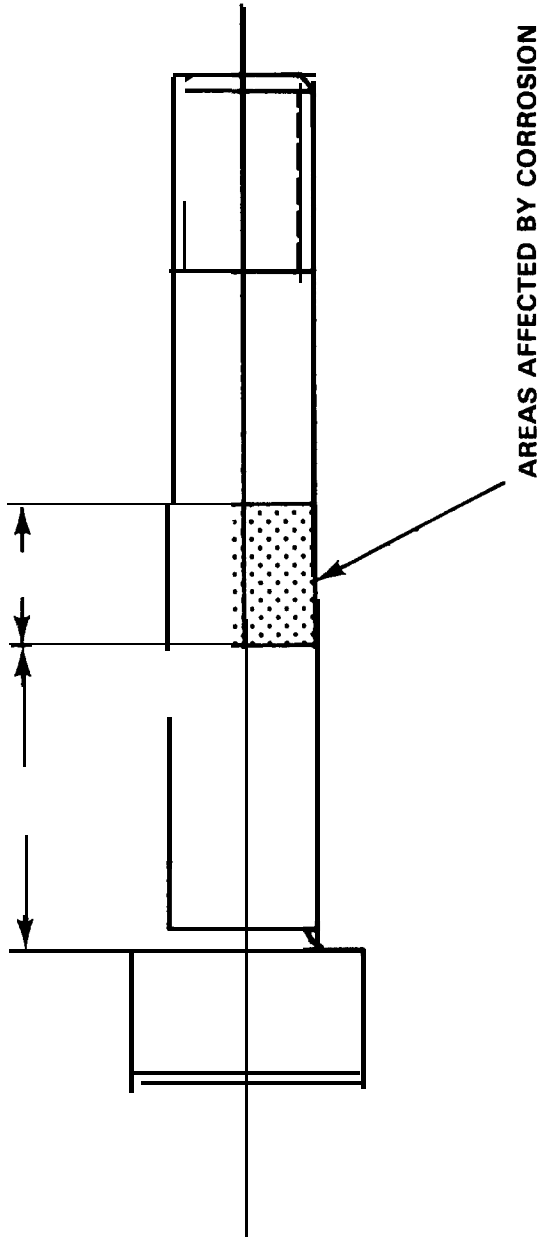
Figure 15 - Coupling Bolt With Corrosion Areas

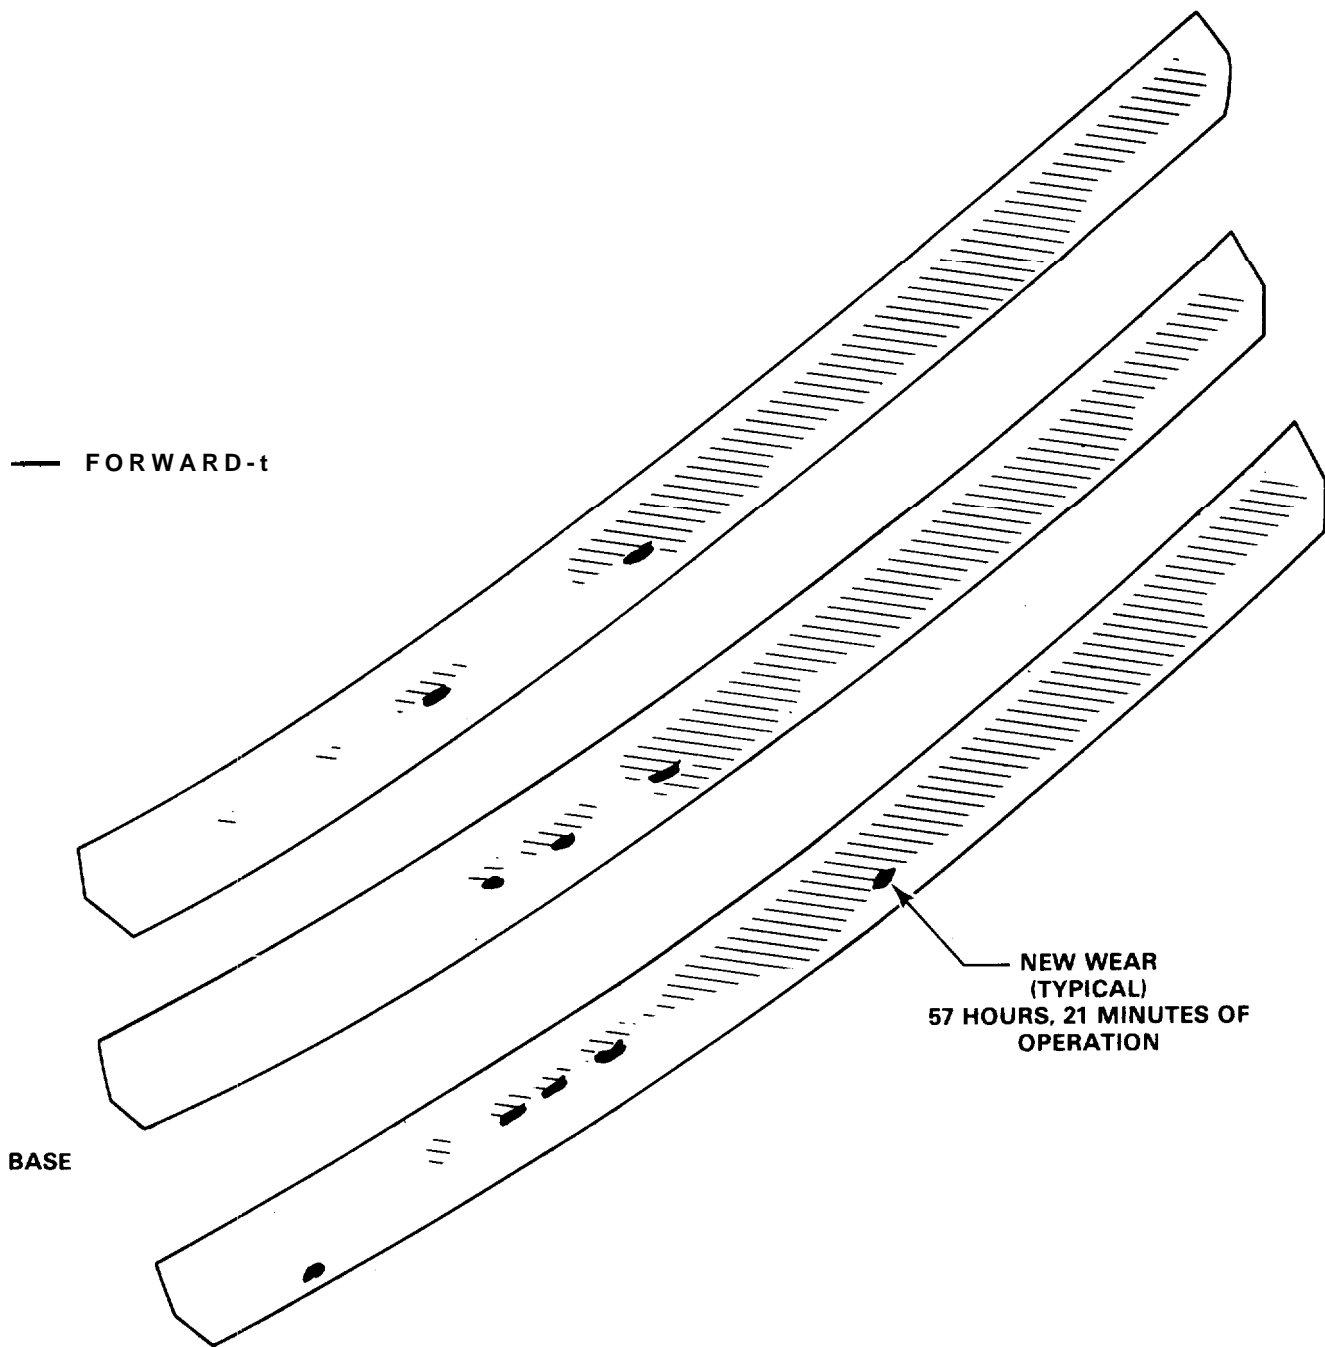
Another inspection of the SI gears was made in March 1972 and detailed by Csaky.<sup>19</sup> A total of 72 hr has been accumulated to this date. The gear teeth showed signs of scuffing with the port gear showing the most wear. The zinc phosphate coating "wearing away" was noted as in previous inspections although the wear did not seem to be serious at this time. It was pointed out that the port SI gears had the root of the teeth on the pinion hand honed to correct an evident error in fabrication. It was recommended by DTNSRDC that a replacement pinion gear for the port SI gearbox be ordered as soon as possible. It was also urged that an inspection of the pinion and idler gears be made after each 10 hr of foilborne operation so that the wear rate of the pinion could be monitored. A sudden increase in wear could cause extensive damage and thus expensive repairs.

Figure 16 - Port Single Idler Gear Teeth and Wear Pattern  
(Left Hand Helix)

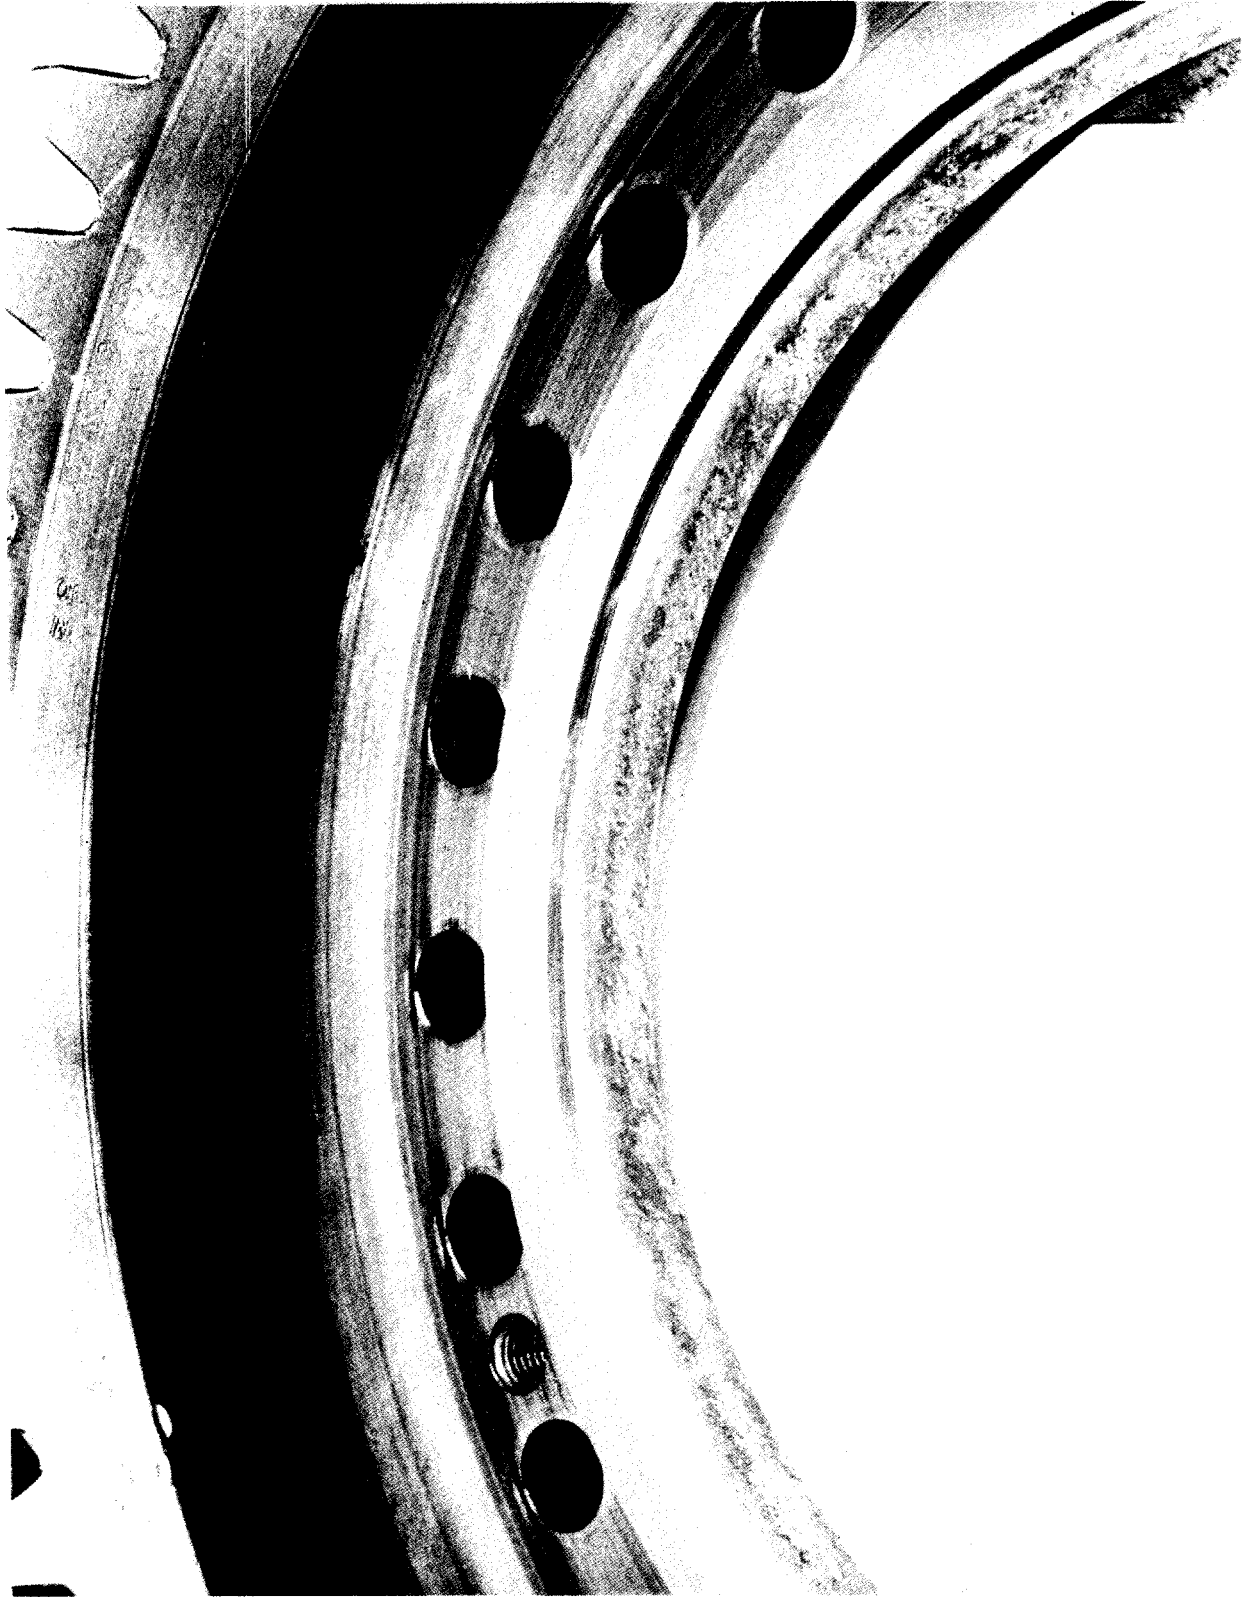
Although only one gear and its mounting surfaces was inspected, there was a suspicion that the other gears were subjected to the same fretting corrosion. This was verified by the 19 December 1974 inspection when the other three bevel gear units were removed from the struts and completely disassembled.<sup>31</sup> The horizontal shafts were removed from the gearboxes and the gears and bearings removed from the shafts. All the shaft inspections displayed moderate fretting on the gear pilot surfaces (Figure 17). The percentage of fretted area on the 16 surfaces varied from 10 to 90 percent with depth of fretting ranging from 0.007 to 0.020 in. The fretting on the base surface of the gear pilot was significantly less severe than on the shaft (Figure 18). On the port lower bevel gears, corrosion depth varied from 0.001 to 0.012 in. as measured in random areas. Figure 19 shows the port lower gear carrier; fretting corrosion is evident on the gear pilot surfaces.

Figure 18 - Ring Gear Fretting Corrosion

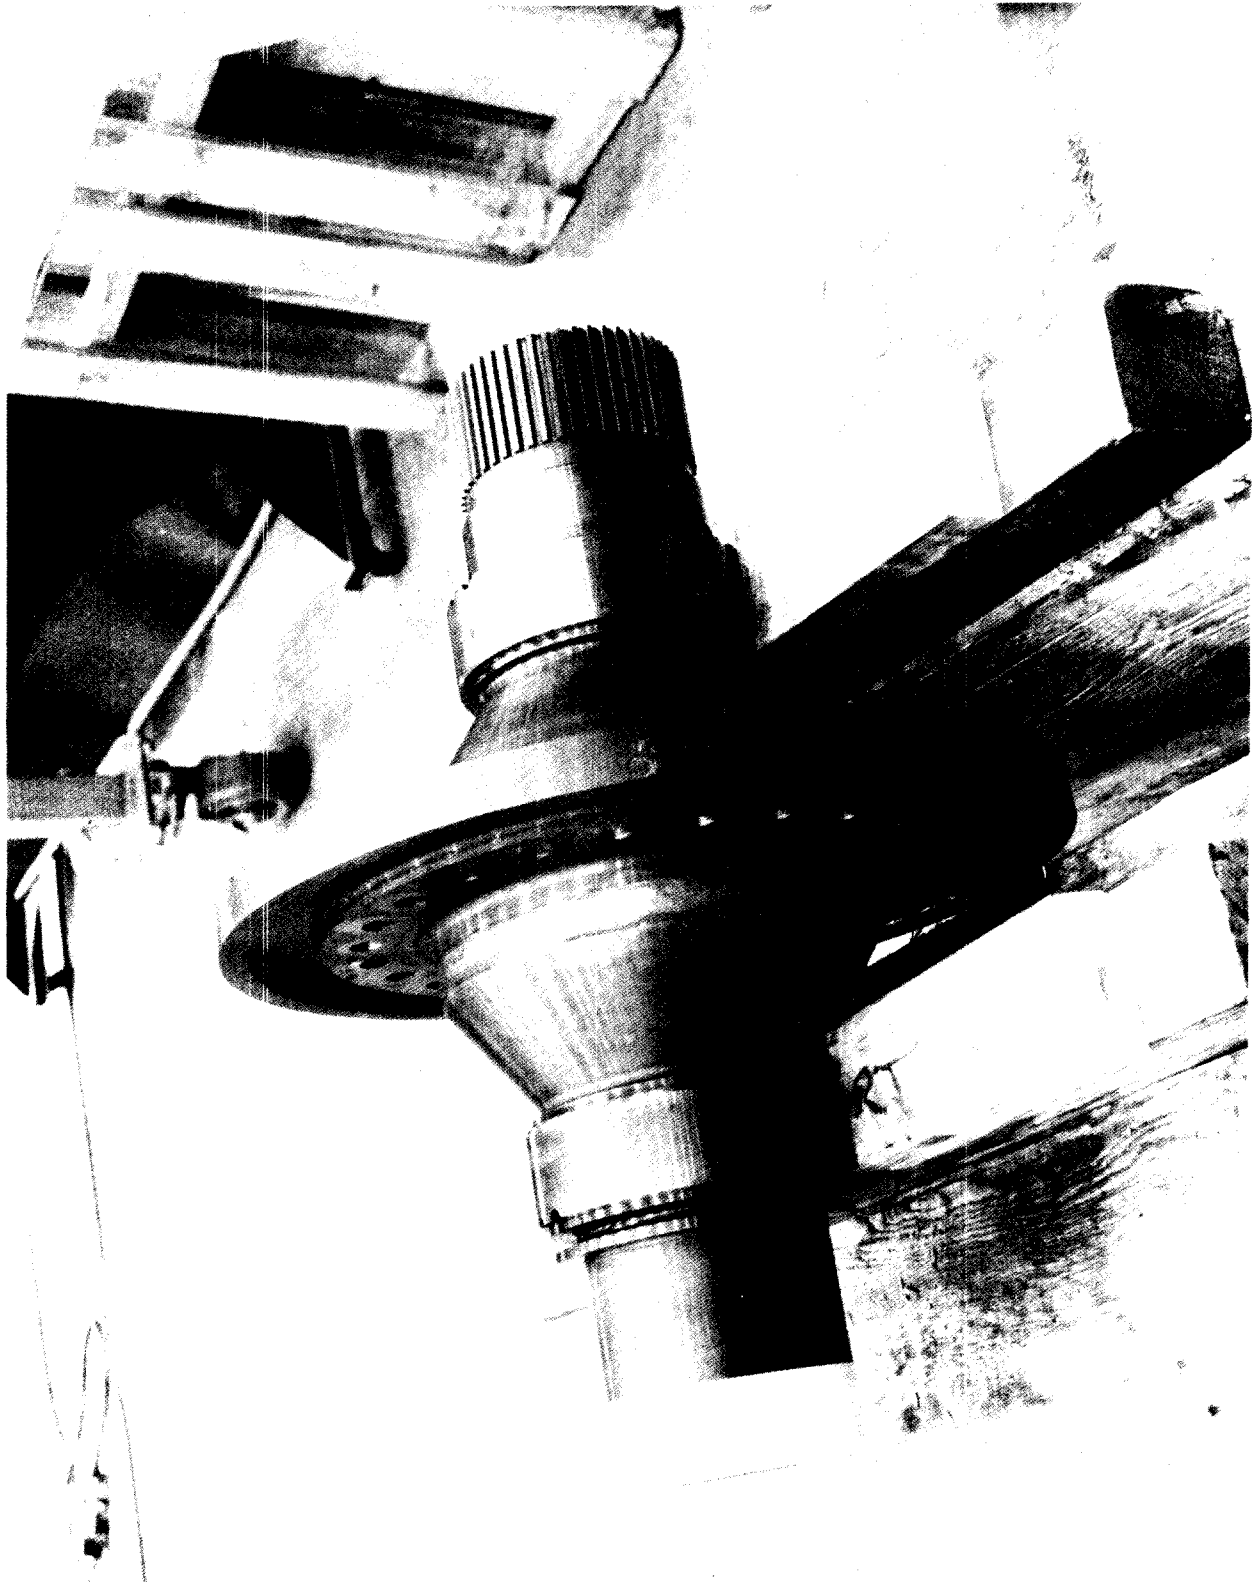
Figure 19 Port Lower Gear Carrier Unit

1. Rust on various parts of the gearbox housing, enough to warrant corrective treatment.
2. Rust spots on most of the bevel gears.
3. Rust on the inner and outer end of the vertical gear shafts.
4. Water in the gearbox housing.
5. Foreign material on various areas of the gearbox housing.
6. Fretting corrosion on the horizontal drive shaft of all four units, at the gear mounting surface and the gear register surfaces.
7. Signs of discoloration, rust, pitting, loss of plating, and oil drain holes plugged with sludge on all bearings.

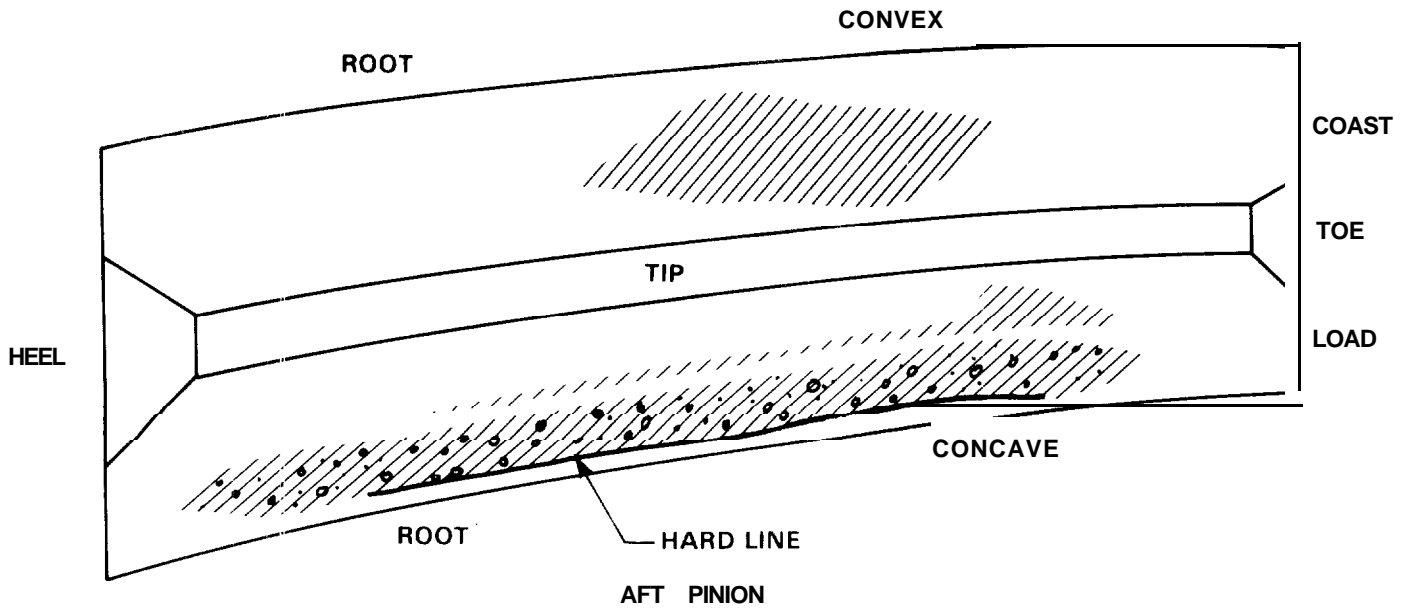
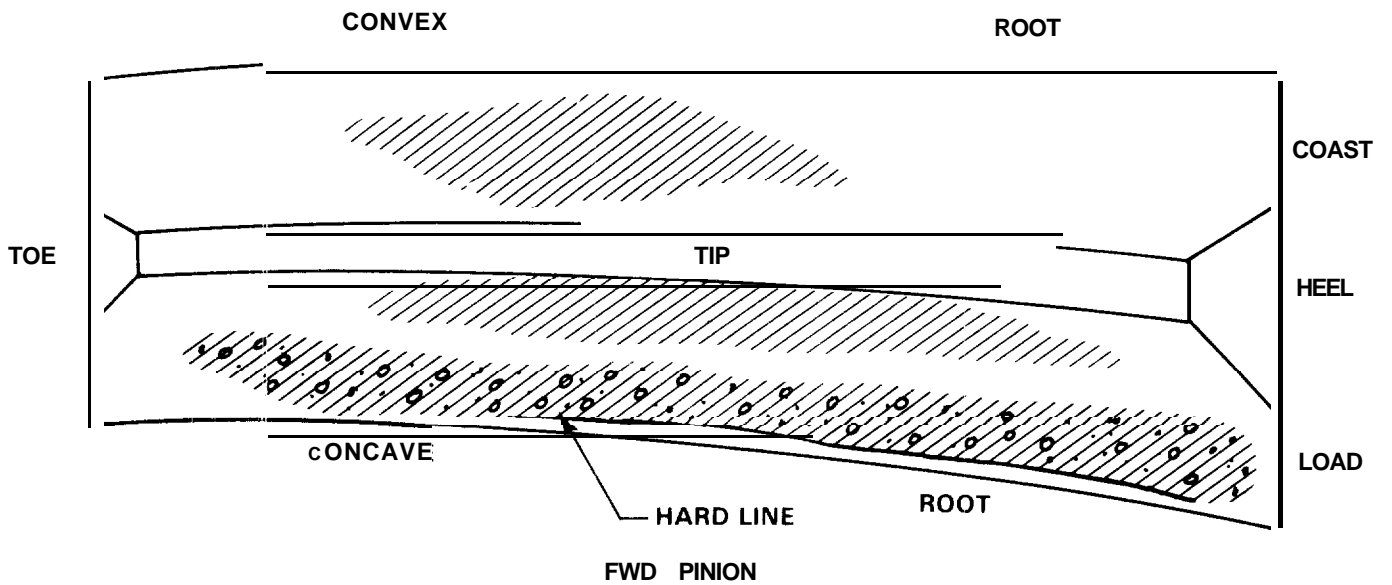
- Wear patterns on load side are just appearing thru the oxide coating.
- Some scattered pitting seen. Not considered a problem.
- Backlash feels all right - by hand turning.

Figure 25 - Tooth Contact Pattern: Port Upper Input Pinions, at 268 Hours of Operation

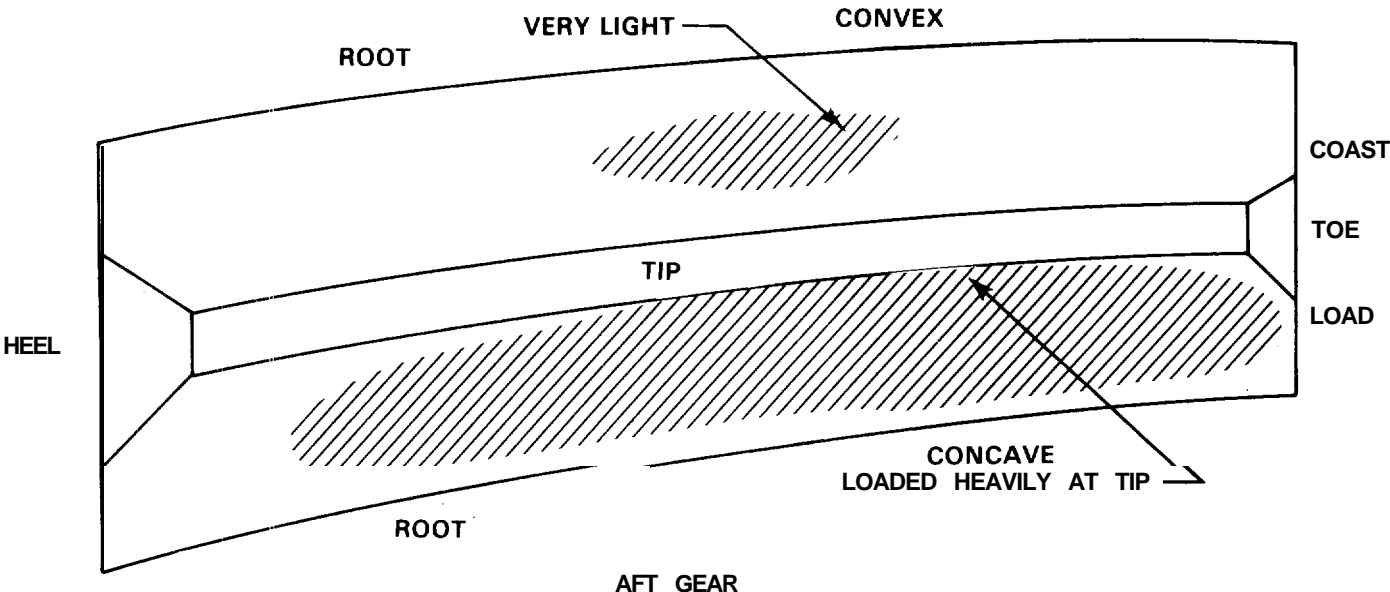
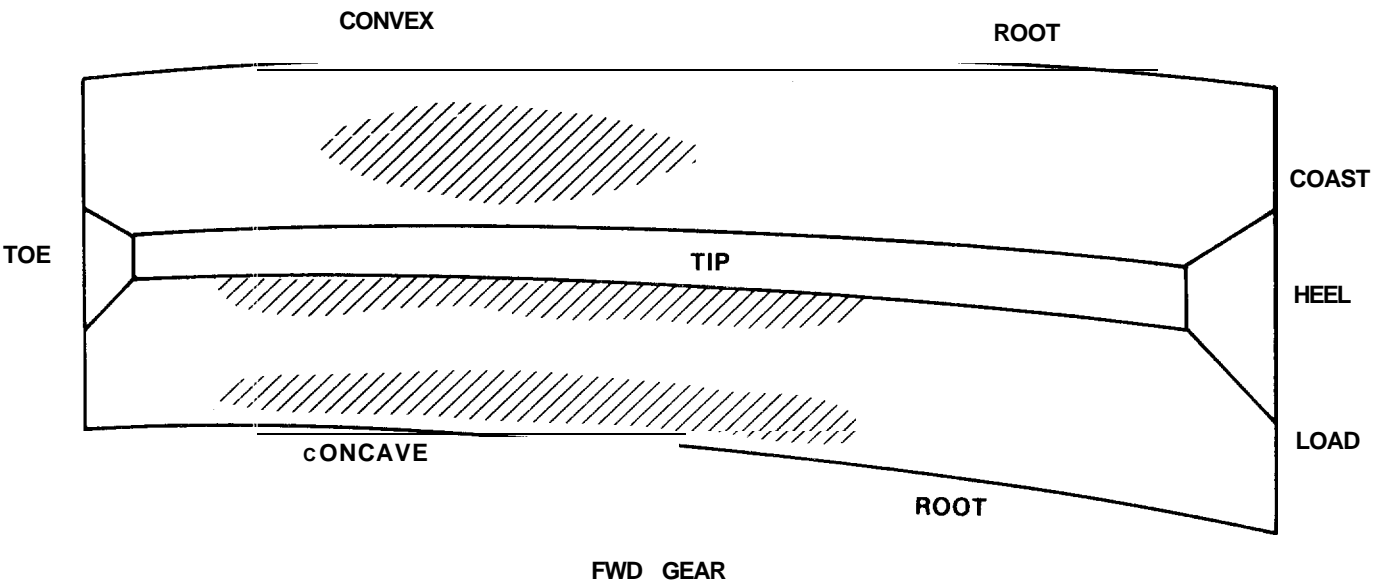
- NOTES:
- Could not move gear for backlash.
  - Wear pattern just appearing.
  - Gears in good condition.

Figure 27 - Tooth Contact Pattern: Port Lower Gears, at 268 Hours of Operation
