**LIFE HISTORY OF USS PLAINVIEW (AGEH-1)  
HYDROFOIL POWER TRANSMISSION SYSTEM**

by  
**Henry W. Schab**

December 1980

DTNSRDC-80/109

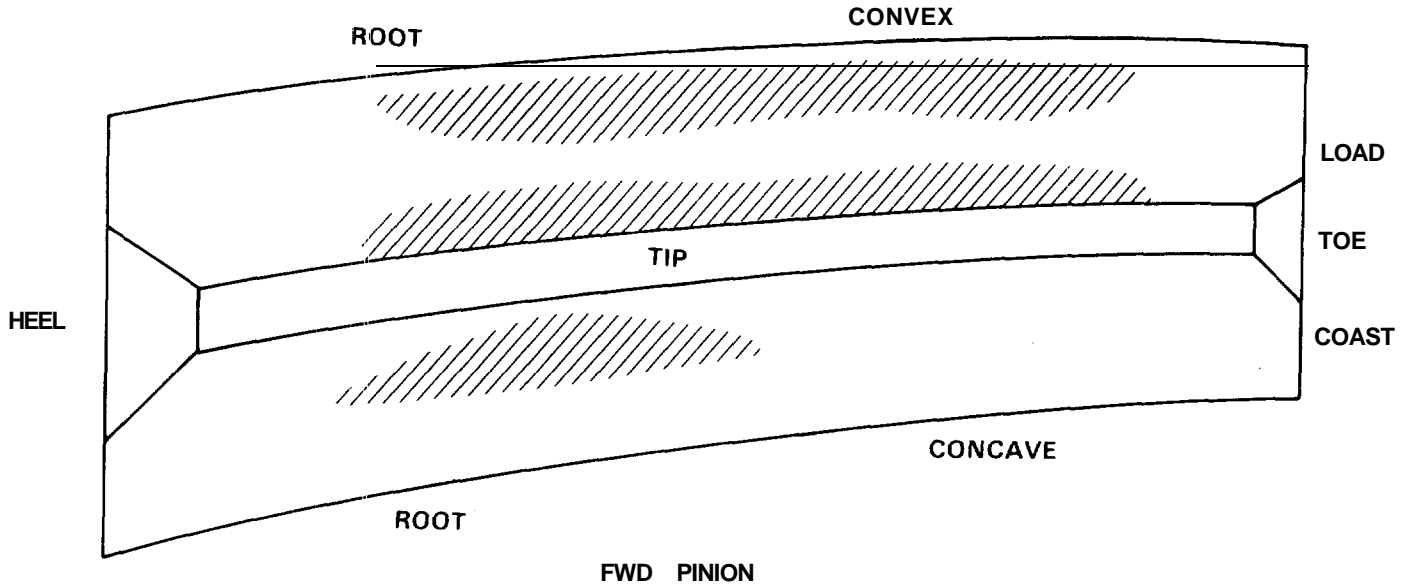
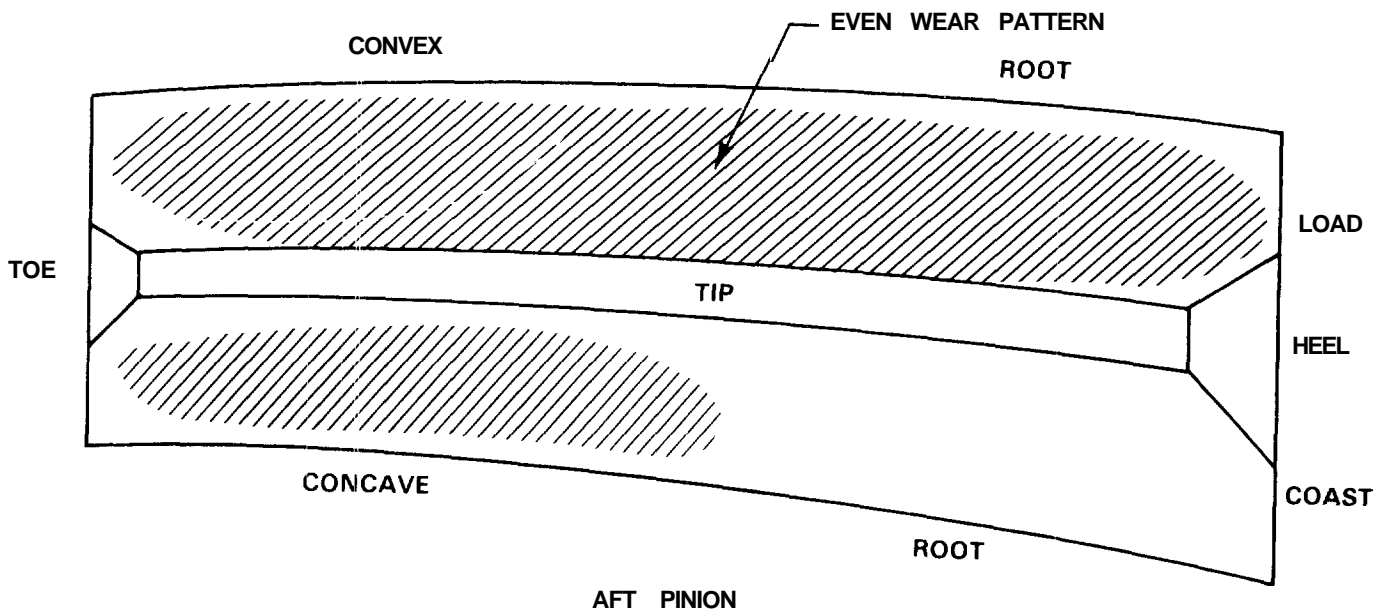
- The two old scoring patterns are tarnished.
- Wear patterns are just appearing thru the oxide coating.
- Pinion in good condition.

Figure 28 - Tooth Contact Pattern: Port Lower Pinion, at 268 Hours of Operation

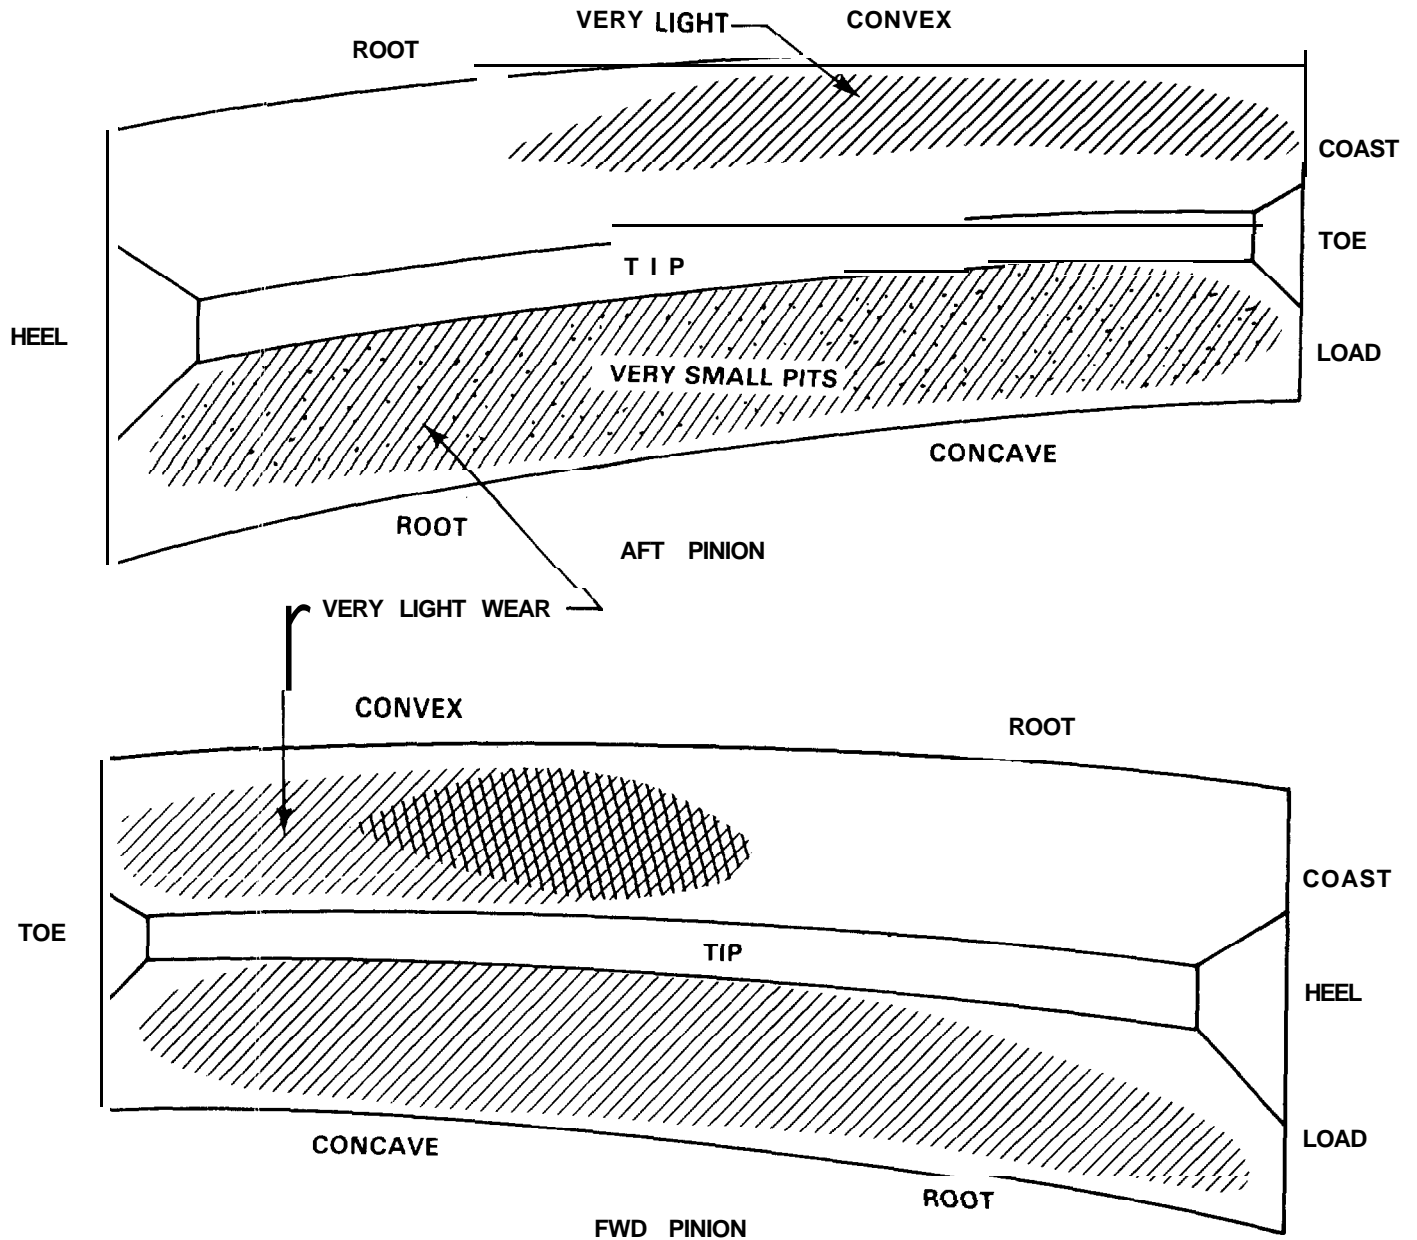
- Wear patterns on load side are just coming thru the oxide coating.
- Backlash feels all right. Seems to be more than port unit.

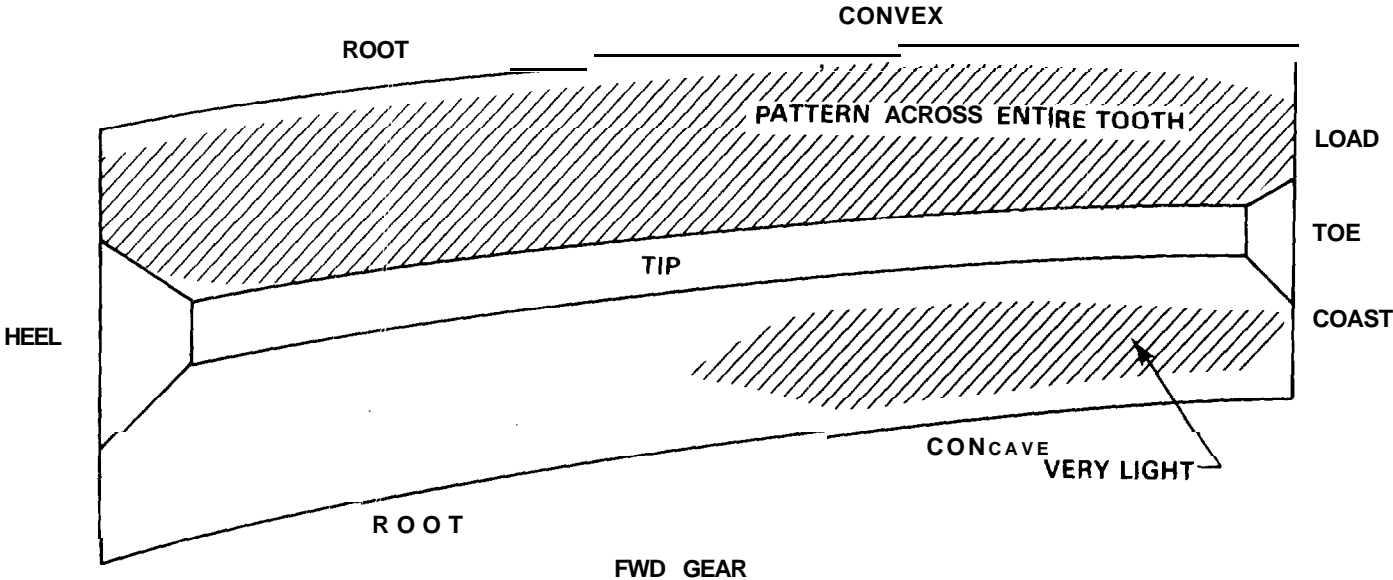
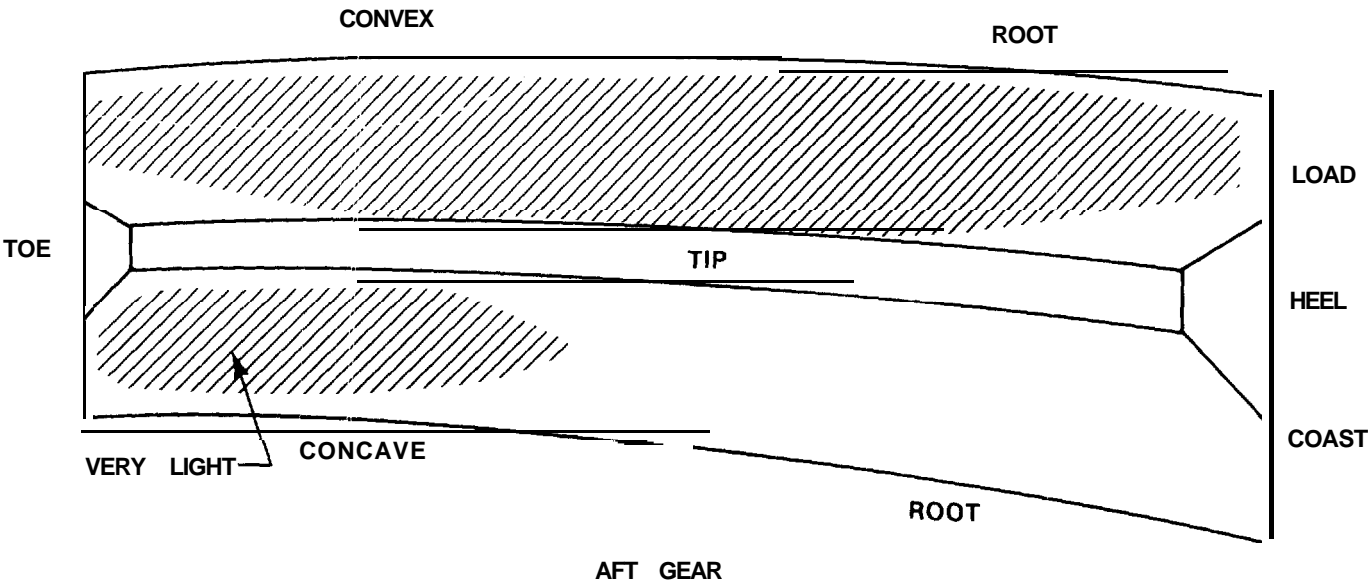
- NOTES:
- Very light wear seen thru the black oxide coating.
  - Gears look very good.

Figure 30 - Tooth Contact Pattern: Starboard Upper Gears, at 268 Hours of Operation

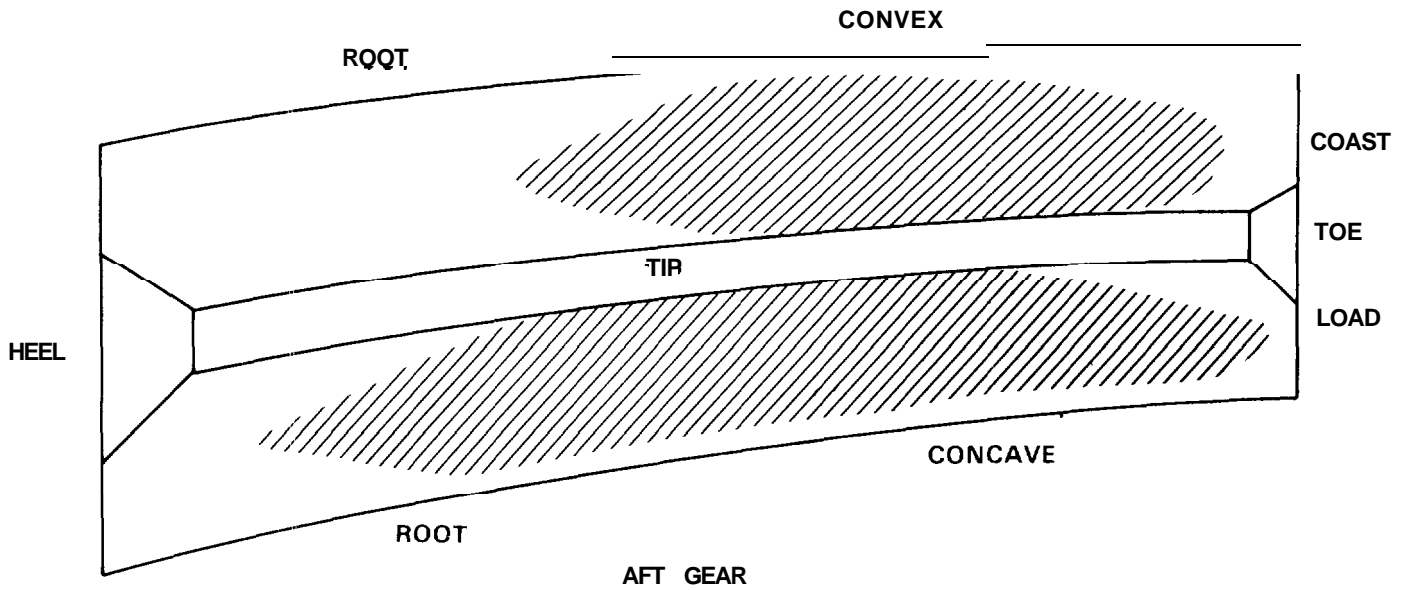
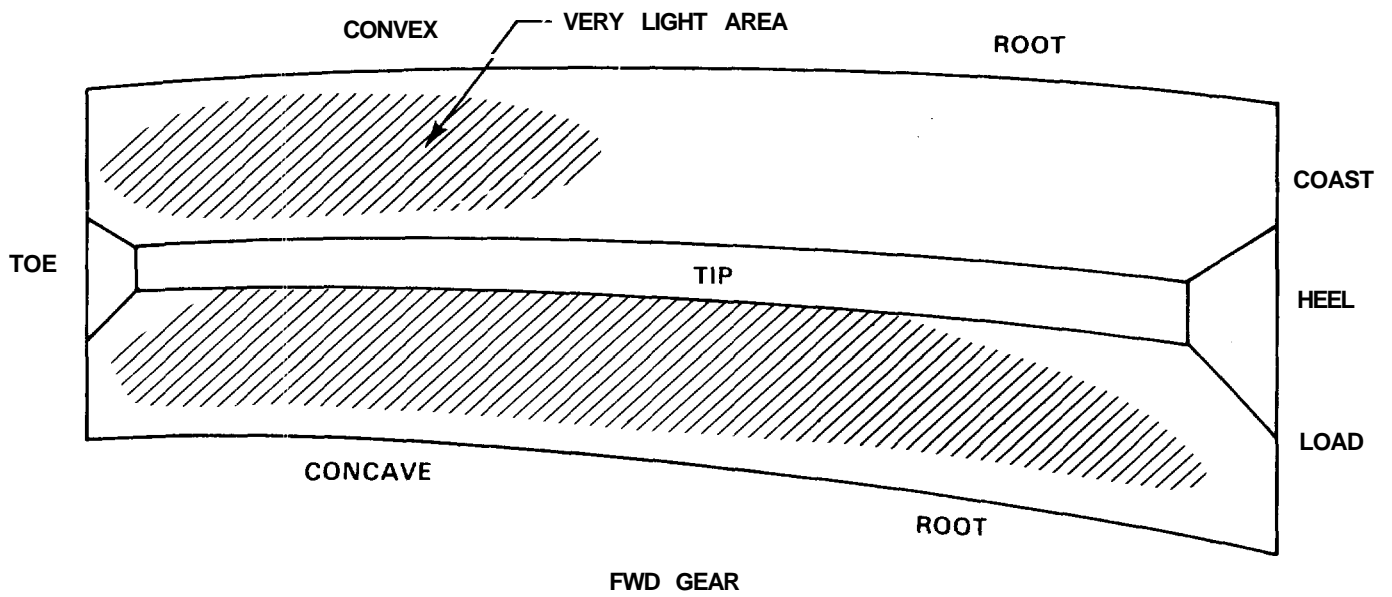
- Wear patterns on load side are just appearing.
- Backlash feels all right.
- Gears look in good condition.

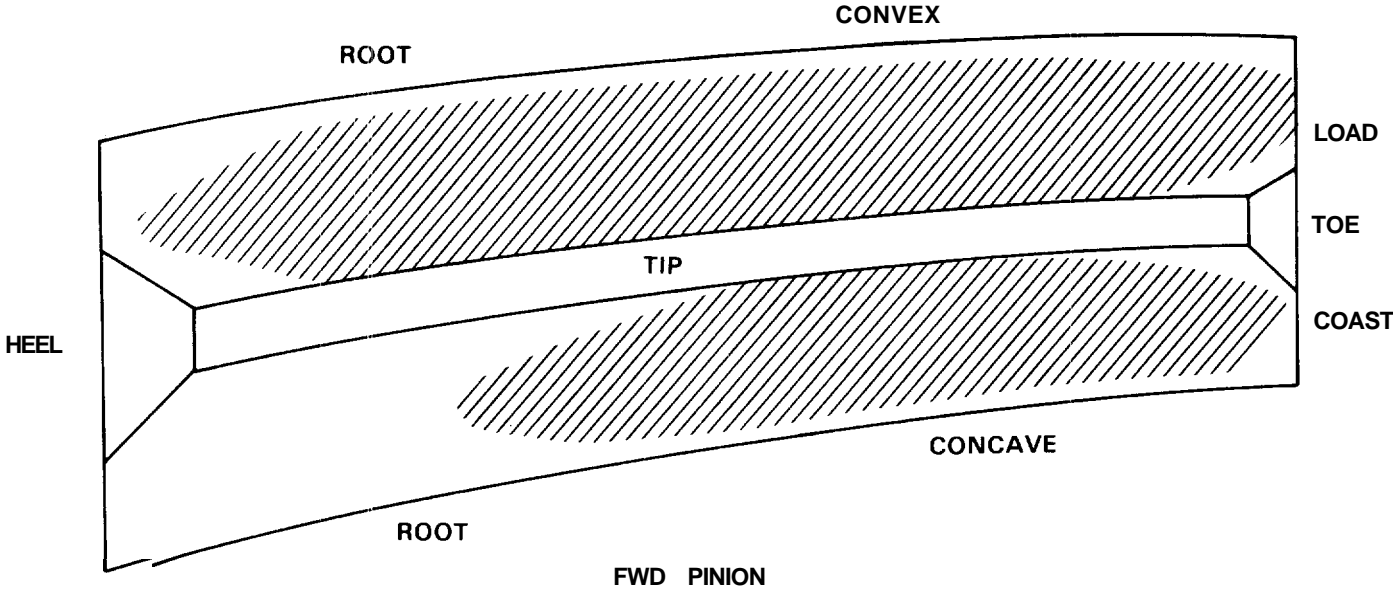
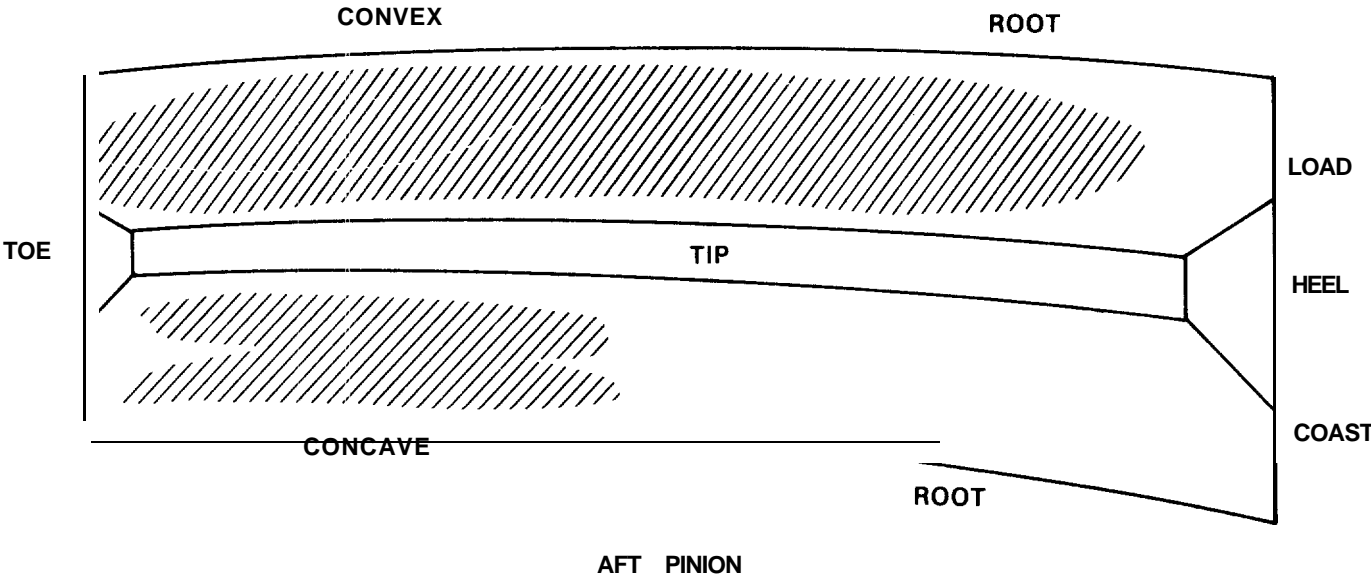
- Wear patterns just starting to appear thru oxide coating.
- Pinion in good conclition.

Figure 32 - Tooth Contact Pattern: Starboard Lower Pinion, at 268 Hours of Operation
