DOCUMENT NO. D321-51134-1 MDDEL IR&D

TITLE EFFECT OF COATINGS ON THE FATIGUE LIFE OF

15-5PH STAINLESS STEEL IN SEA WATER

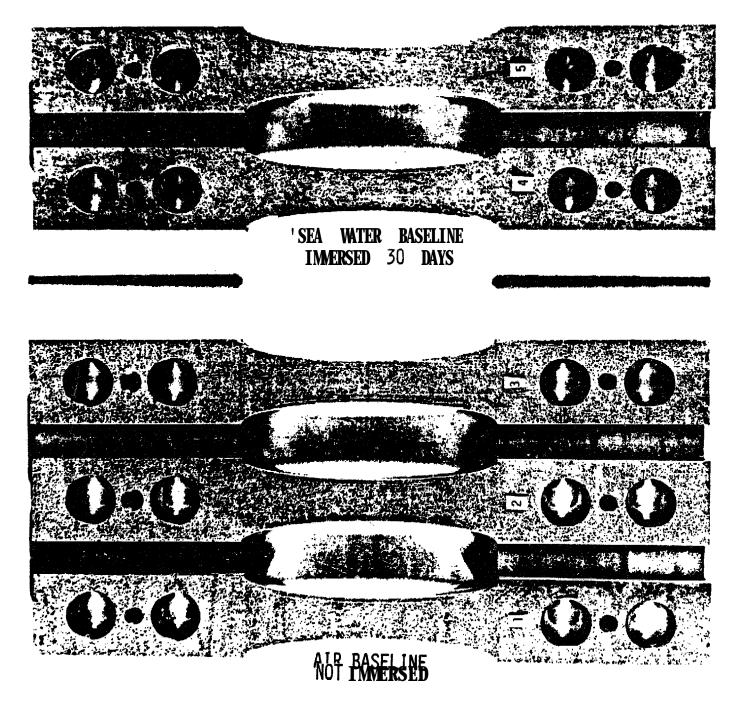
## FIGURE 3

## UNCOATED SPECIMENS

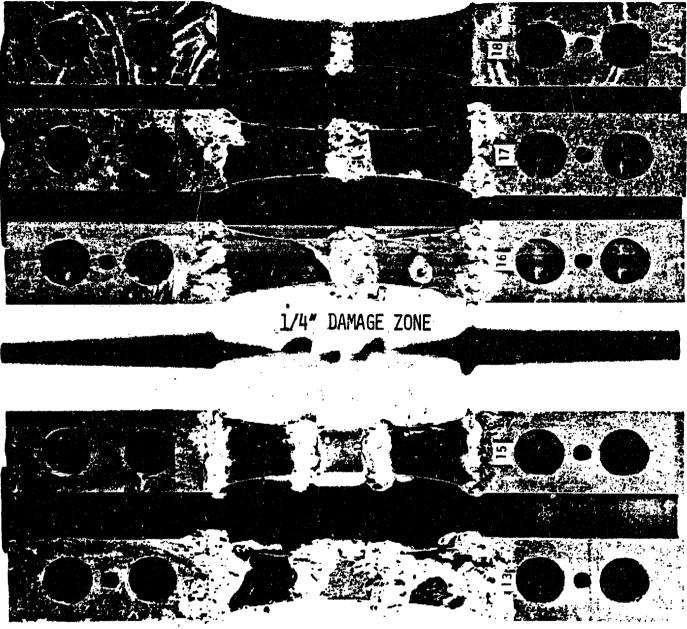
Examination of the exposed specimens and the fatigue test results indicates that the galvanic protection of the flame sprayed aluminum adequately protected the 15-5PH base metal from crevice attack during the sea water exposure and test period. The corrosion of the aluminum does create a voluminous corrosion product. The aluminum substrate, therefore, does provide adequate short term protection to the substrate and maintains the air fatigue properties in spite of any damage to the top urethane coating. The creation of the corrosion product does limit the protection to short time periods. As a consequence, the top coating should be repaired as soon as any damage is noted to minimize the extensive lifting of the urethane topcoat by the corrosion product.

I" DAMAGE ZONE

FIGURE 4 ALUMINUM FLAME SPRAYED SPECIMENS WITH PR 1654 OVERCOAT AFTER 30 DAY IMMERSION

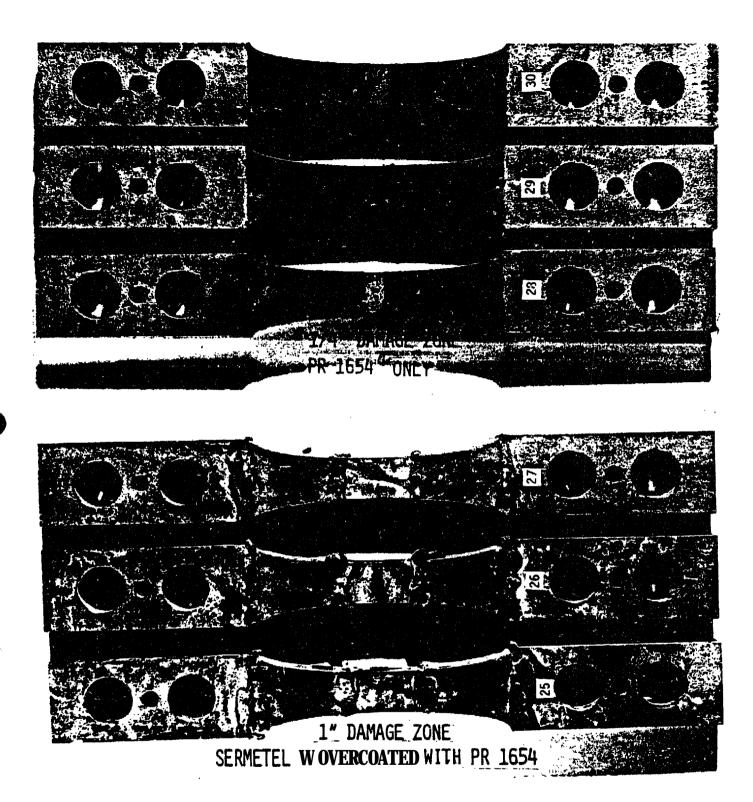
Under the test conditions the Sermetel coatings did not protect the specimens. This lack of protection could be related to the ratio of the Sermetel coated area to the bare area, to the processing of the coating after disposition and the specimen preparation prior to coating. Additional study is being conducted to determine if the Sermetel coatings will provide short term protection.

FIGURE 5 COATED SPECIMENS AFTER 30 DAY IMMERSION
