DTNSRDC/SDD-83/11

**TECHNICAL EVALUATION
OF THE RHS 200
FOR HIGH SPEED FERRY APPLICATION**

Donald F. Rieg and James H. King

DECEMBER 1983

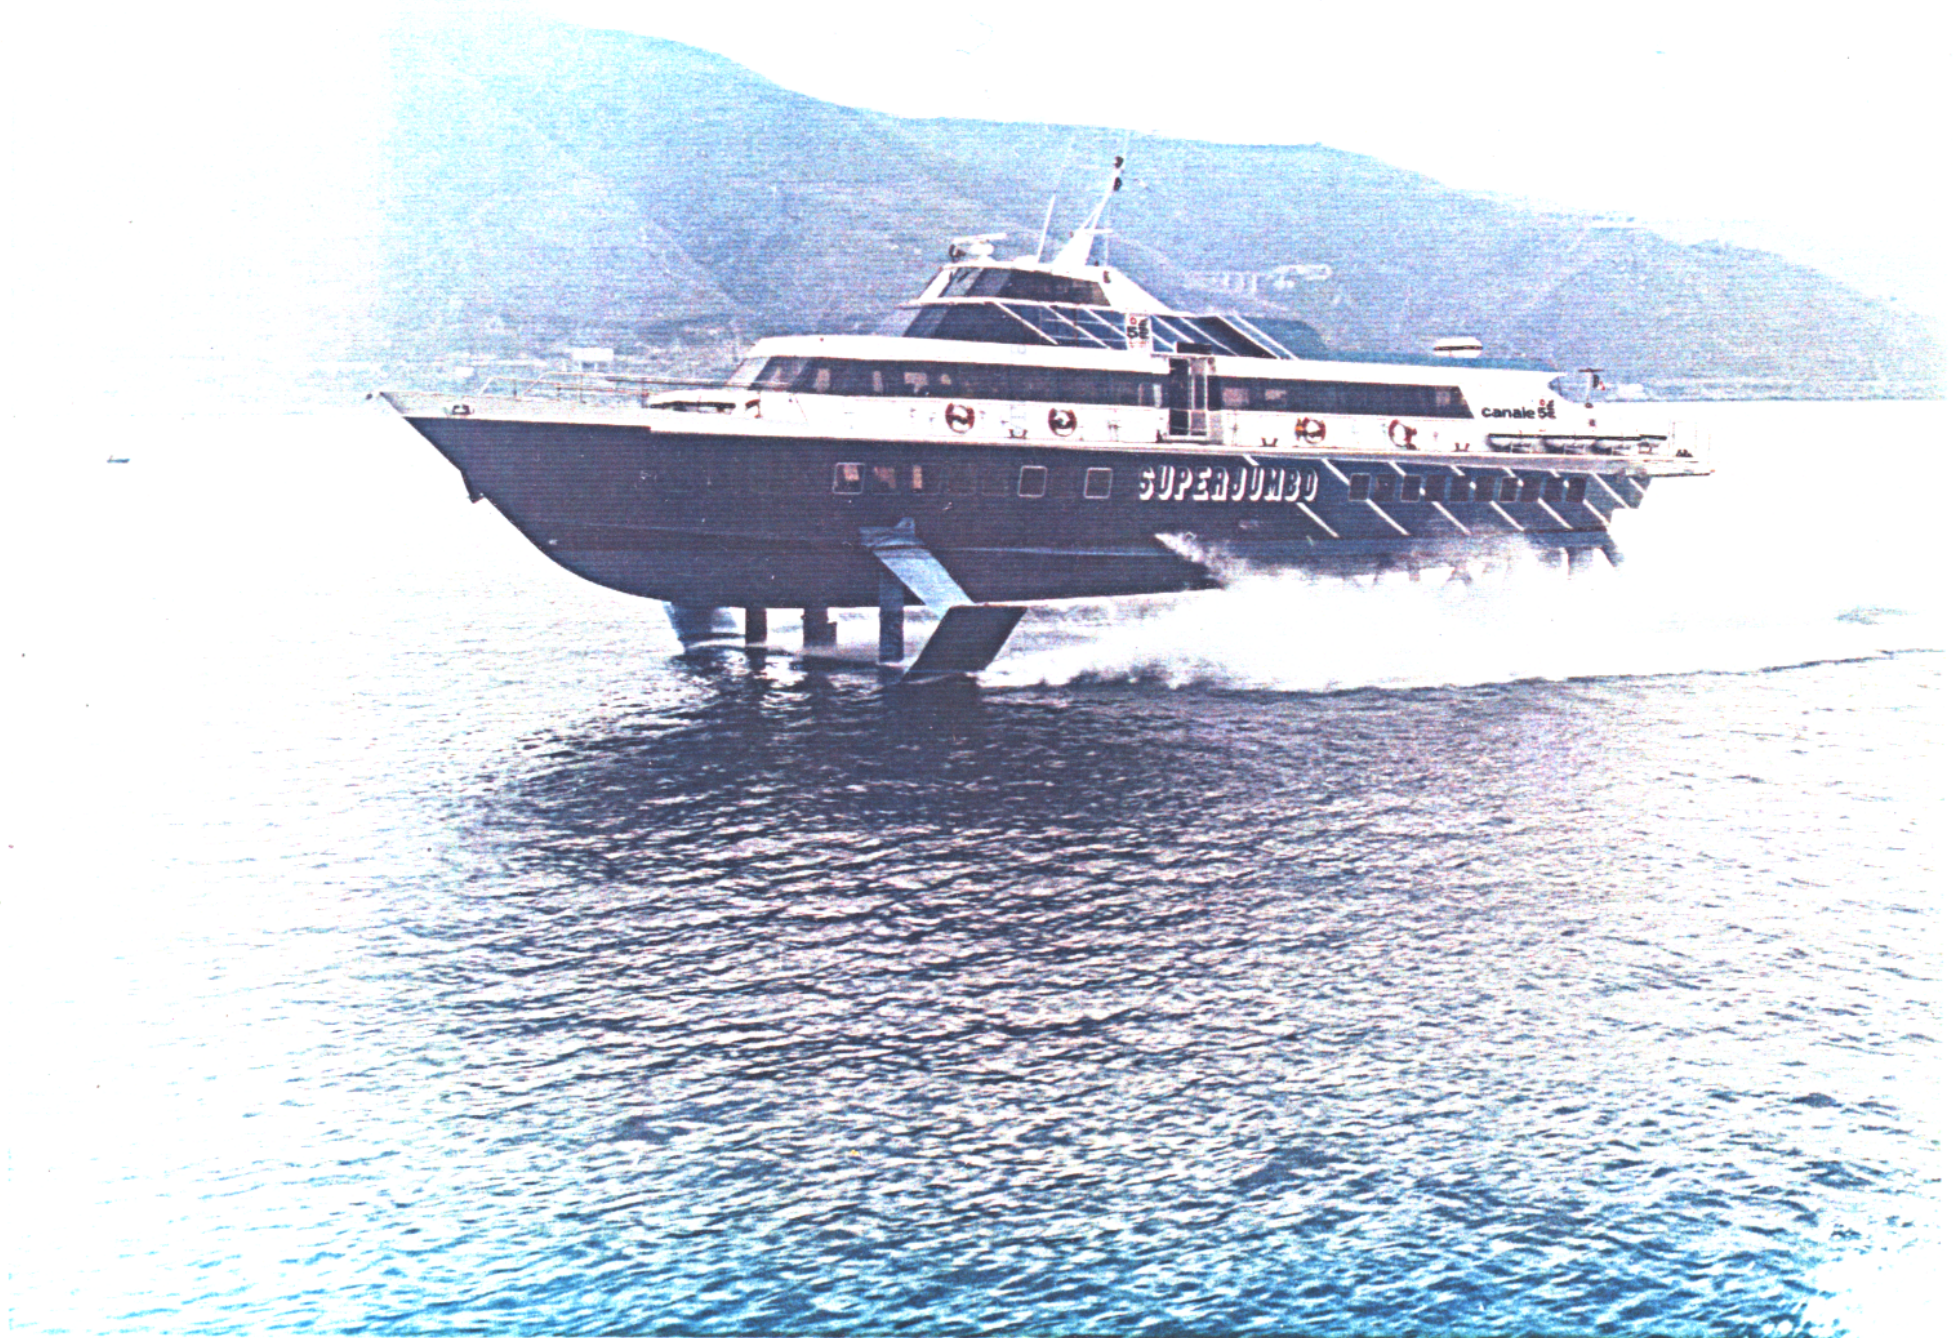
Figure 1. RHS 200 Hydrofoil (SUPERJUMBO)

The RHS 200 SUPERJUMBO, shown in Figure 1, is designated Rodriguez hull number 192 and is the prototype of a new series of surface-piercing hydrofoil ships being developed by Rodriguez for use as high speed passenger ferries. Inboard and outboard profiles, deck plans, and other general information descriptive of the RHS 200 type hydrofoils are given in Figures 2 and 3. These figures have been developed from similar information presented in Reference (3). The overall length of the RHS 200 is 117.5 feet, and the beam of the hull is just under 23 feet. Because the surface-piercing foil systems are non-retractable, they are the controlling factors on overall beam and ship draft. Maximum width, or span, across the foils is 47.2 feet. Maximum draft is approximately 15 feet when the ship is pierside or is operating in the hullborne mode. In the foilborne mode, the ship operates with a draft of 6.8 feet. The ship was designed to a displacement of 125 tons. The displacement is 133.8 tons at the overload condition with full passenger, baggage, fuel and liquids, and crew load. A full load displacement of 123 tons is targeted for follow-on ships. The normal fuel capacity is 5.9 tons.

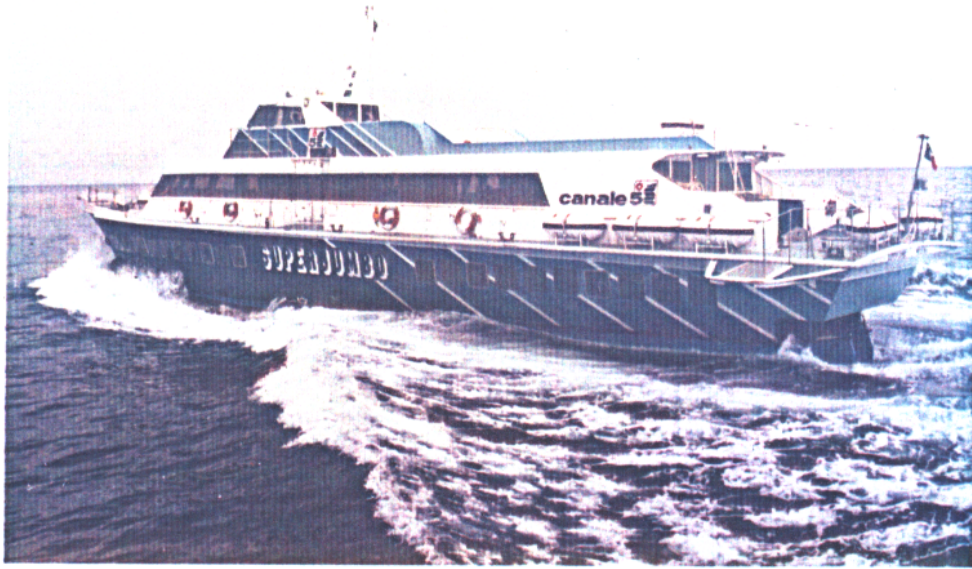
RHS-200 During Landing

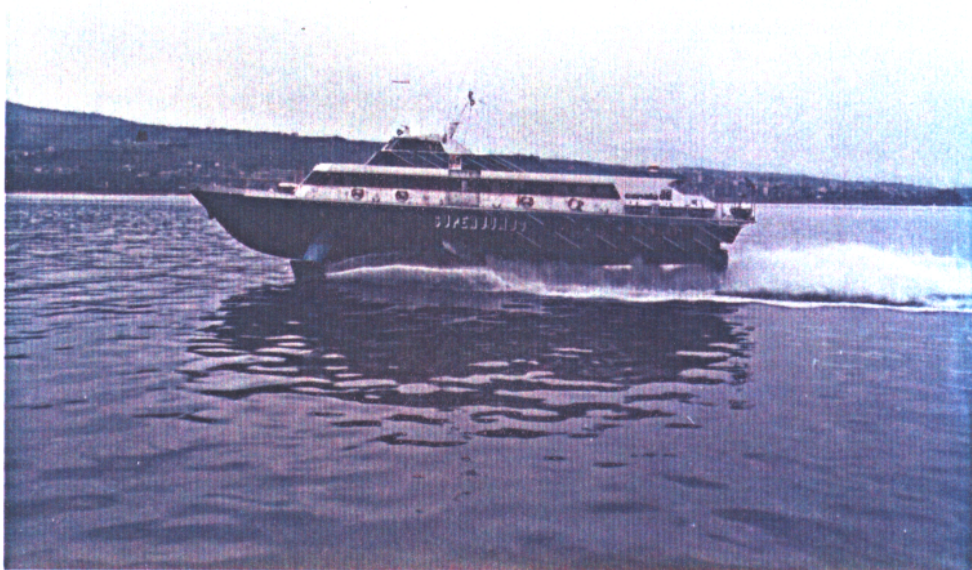
RHS-200 During Takeoff

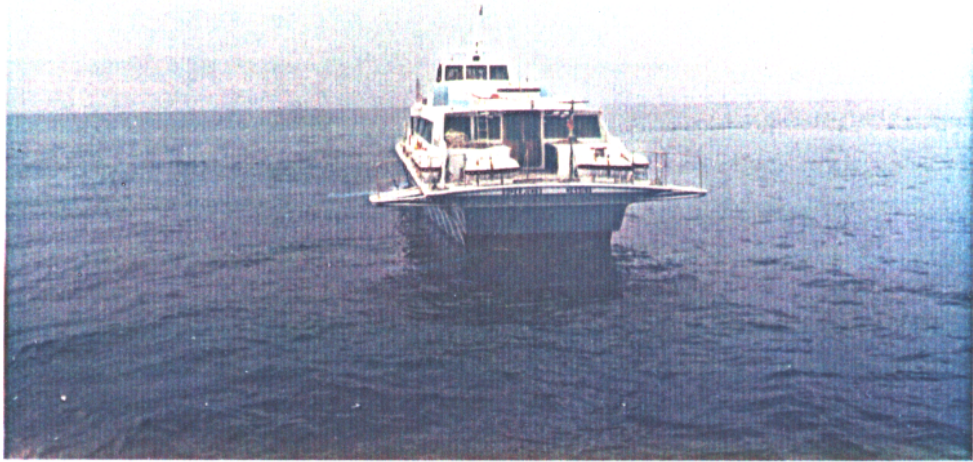
RHS-200 Hullborne - DIW

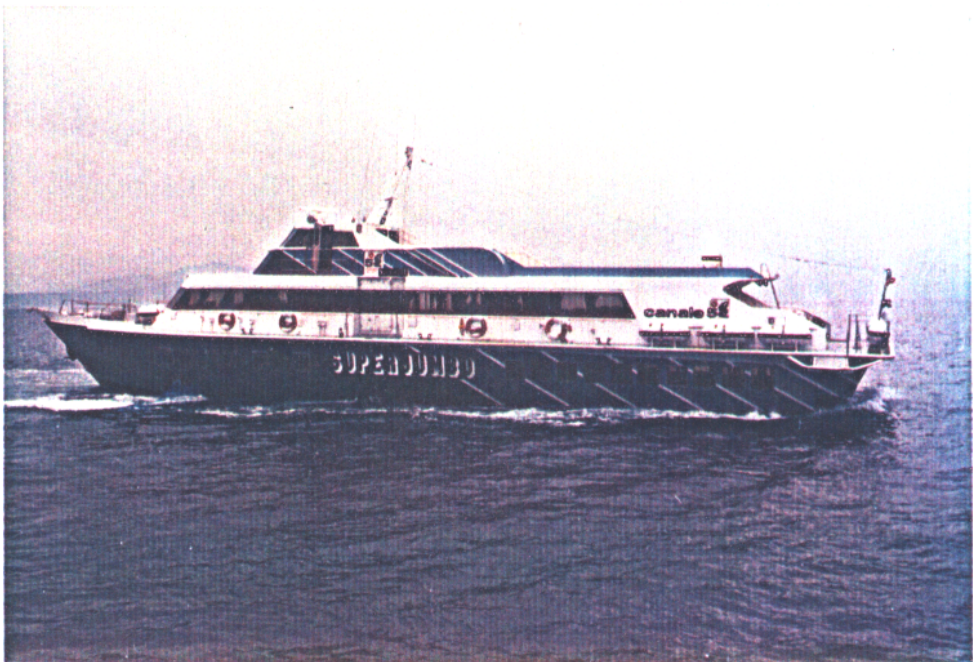
RHS-200 Hullborne - Backing Down
