HIGH SPEED CRASH OF *FRESH-1*

by William M. Ellsworth

Reprinted from the book *Twenty Foilborne Years -- The US Navy Hydrofoil HIGH POINT PCH-1*

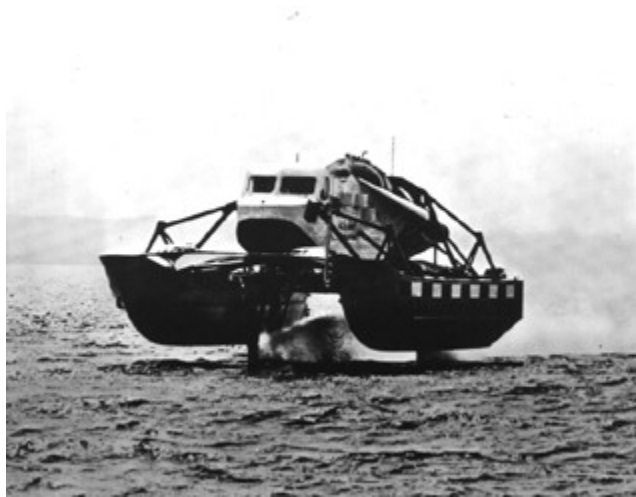
On 18 July 1963, Acceptance Trials with *FRESH-1* in a [canard foil configuration](#) were scheduled. Supervisor of Shipbuilding (SUPSHIP-13) representative Pete Sias was aboard and occupied the co-pilot seat. Vern Salisbury, Boeing test pilot, as usual occupied the left seat at the controls. Salisbury, a Colonel in the Marine Corps Air Reserve, had been recruited from the Boeing flight line where he had been a test pilot for several years. In the rear seat, Bob Hubbard, manager of the Boeing autopilot development team, manned the instrument station. Data from the extensive instrumentation suite was recorded and also telemetered to a shore station where it was continually monitored by Boeing engineers during trials. The trial on that afternoon was ill-fated. During the high speed run, the craft completely capsized. In a taped interview of Vern Salisbury on 22 February 1984, he recalled events during the accident.

[9 May 98] As for the "The Fate of *FRESH-1*", Bill Ellsworth's article is not clear as to the cause of the accident. I being Pete Sias's assistant on this project as well as the *HIGH POINT* construction project, was assigned to the accident investigation board. It was determined that the cause of the accident started from the foils ventilating to the extent that the trailing edge flaps were working in air rather than water. Previous to the accident, Bob Hubbard in the co-pilot seat would see the upward drift on height and manually increase the flap angle to regain fluid flow over the foil before full ventilation occurred. In studying the combination of traces from the telemetered data, it turned out that a combination of the rewetting of the foils at the particular moment that the helm inputs to the trailing edge rudder which was also ventilating and rewetting caused the roll over of *FRESH-1*. The board concluded that if the helm was held steady and throttles were chopped, the ship would most likely have landed on the hull without the roll over. Other safety features were recommended and incorporated, including an escape hatch and push to release door locks.
